**FINAL REPORT
FOR
MILLVILLE TCE
PRELIMINARY ASSESSMENT
MILLVILLE, MASSACHUSETTS**

Prepared For:
U.S. Environmental Protection Agency
Region I
Office of Site Remediation and Restoration
5 Post Office Square, Suite 100
Boston, MA 02109-3912

Submitted by:
Weston Solutions, Inc.
Region I
Superfund Technical Assessment and Response Team IV (START)
101 Billerica Avenue, Building 5, Suite 103
North Billerica, Massachusetts 01862
February 2017

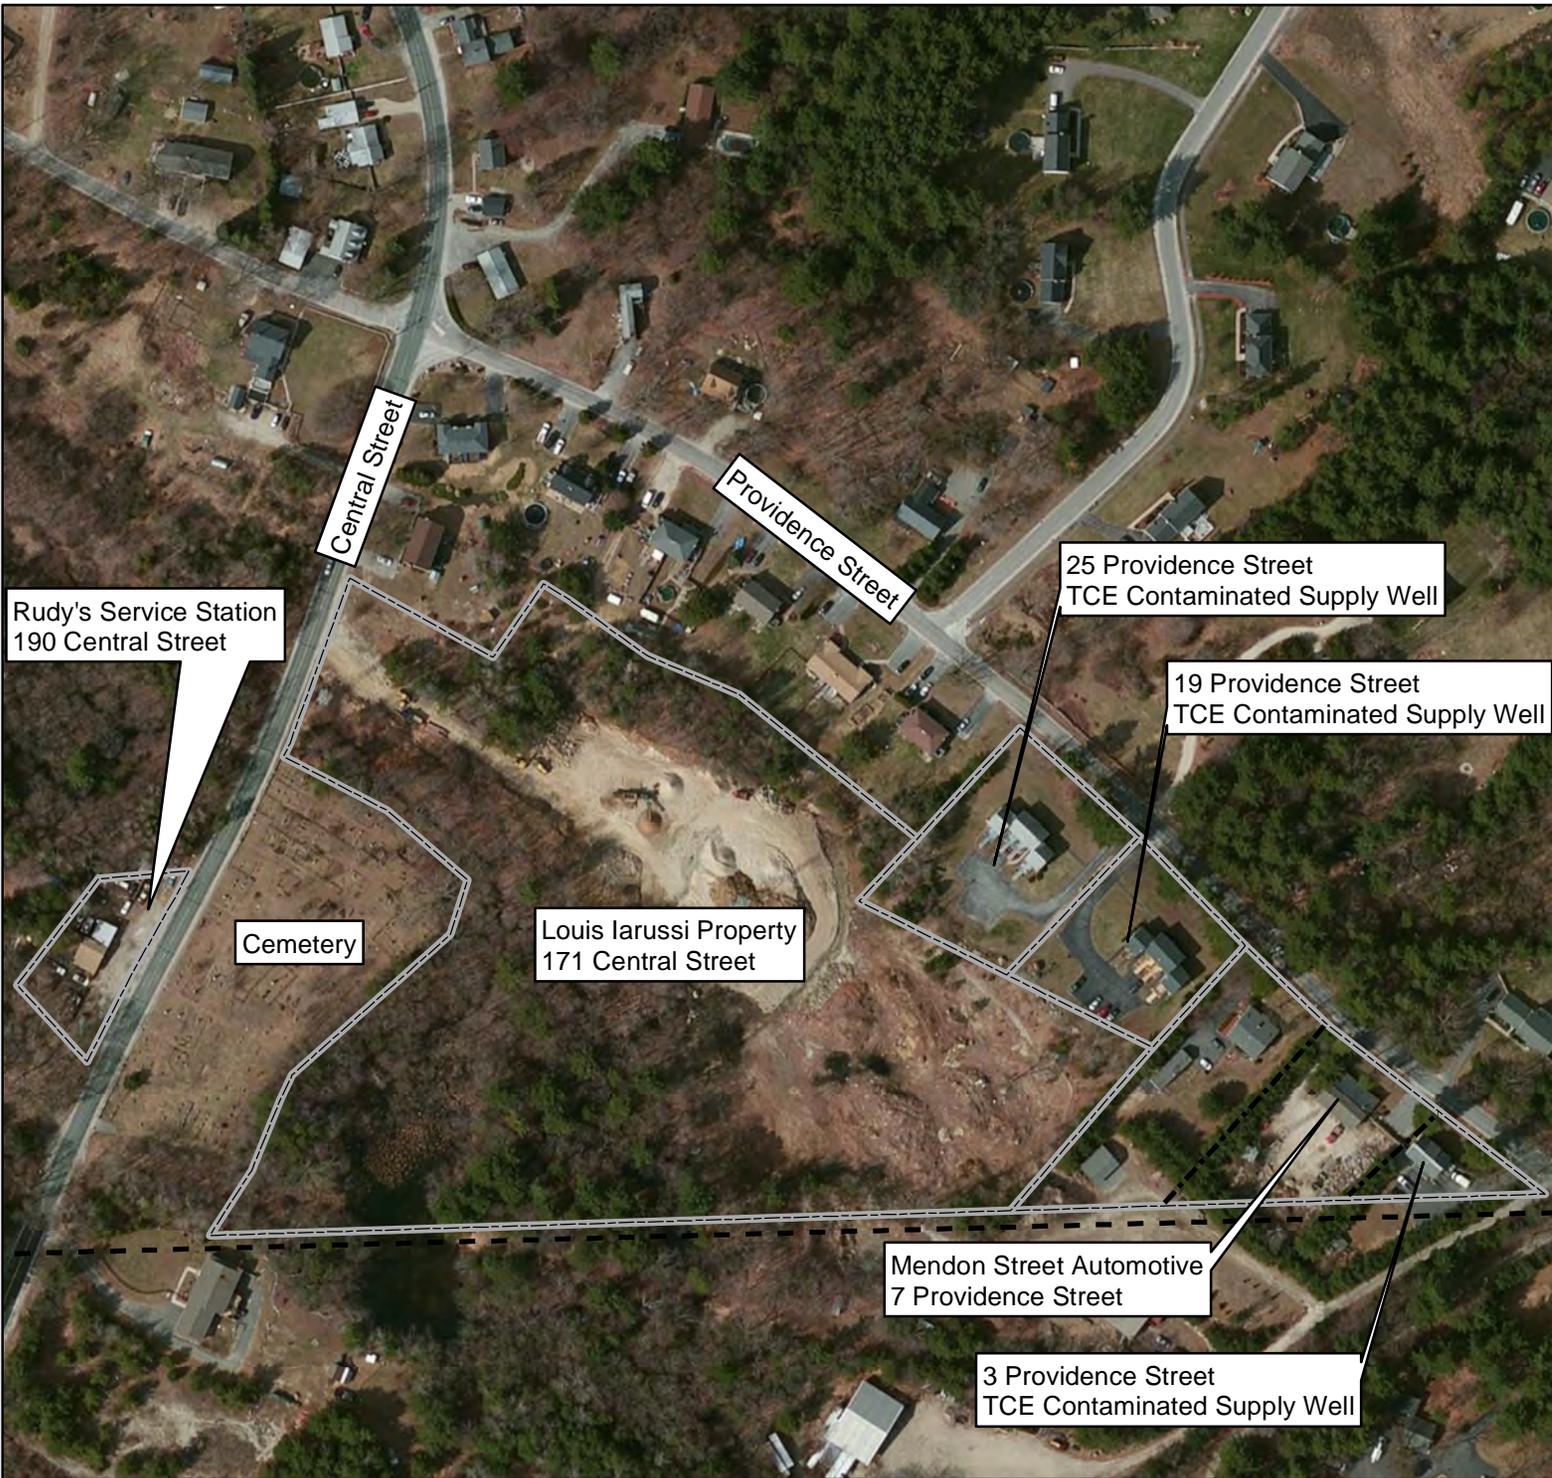
Figure 2

General Site Diagram

properties: 19 and 25 Providence Street (a shared well serving both properties), and 3 Providence Street (located in the vicinity of 19/25 Providence Street) (see Attachment A, Figure 2).

For the purpose of this PA document, the Millville TCE site is considered the general area on and around the 19/25 Providence Street properties where the contamination was first identified and which contains elevated concentrations of TCE and PCE. Elevated levels of contamination have been documented in drinking water samples from residential supply wells on the following properties: 19 and 25 Providence Street (a shared well serving both properties) and 3 Providence Street (located in the vicinity of 19/25 Providence Street) (see Attachment A, Figure 2).

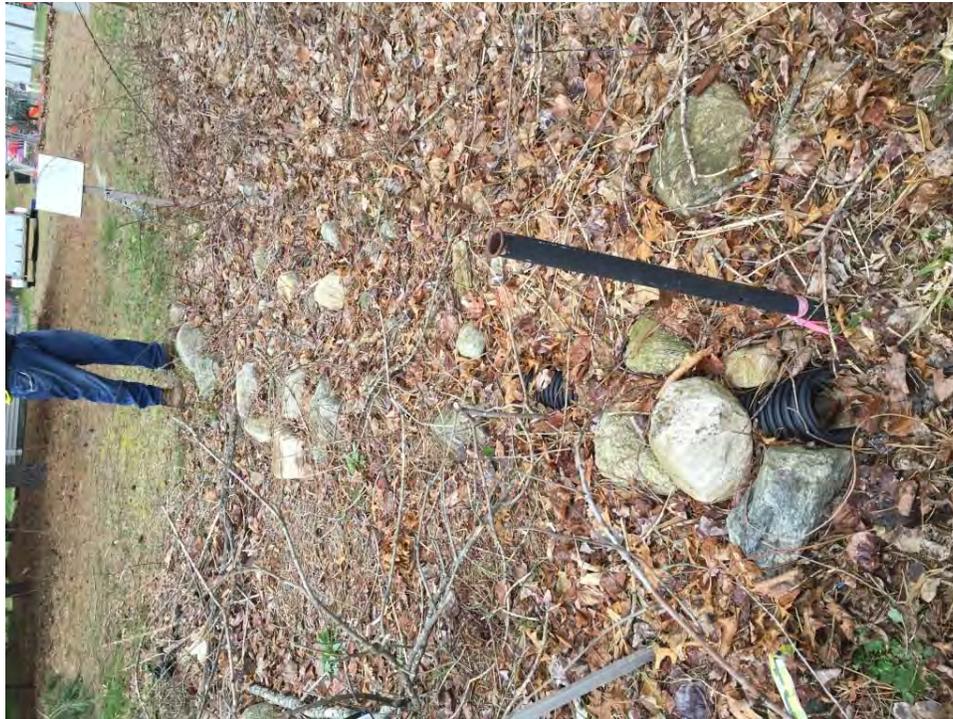
SCENE: View of a 6- to 8-inch corrugated plastic drainage pipe leading from the adjacent residence's property to the 171 Central Street property. Photograph taken facing northeast.

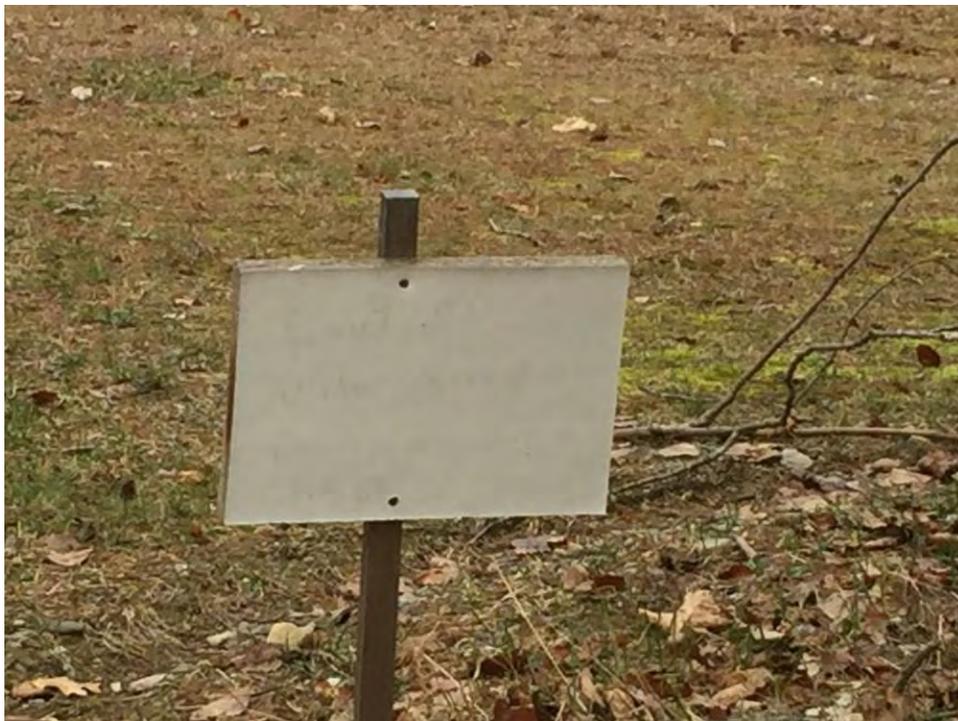
SCENE: View of faded sign adjacent to corrugated plastic drainage pipe indicating that it drains from the road ("Caution Underground Pipe from Road"). Photograph taken facing northeast.

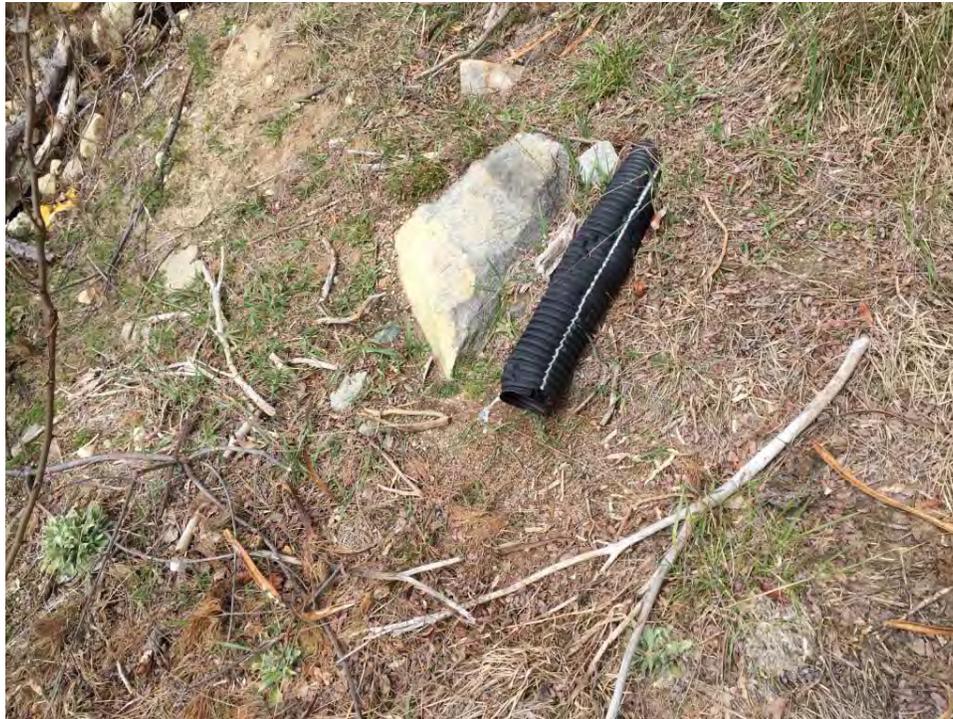
SCENE: View of a 6- to 8-inch corrugated plastic drainage pipe leading from the adjacent residence's property to the 171 Central Street property. Photograph taken facing north.

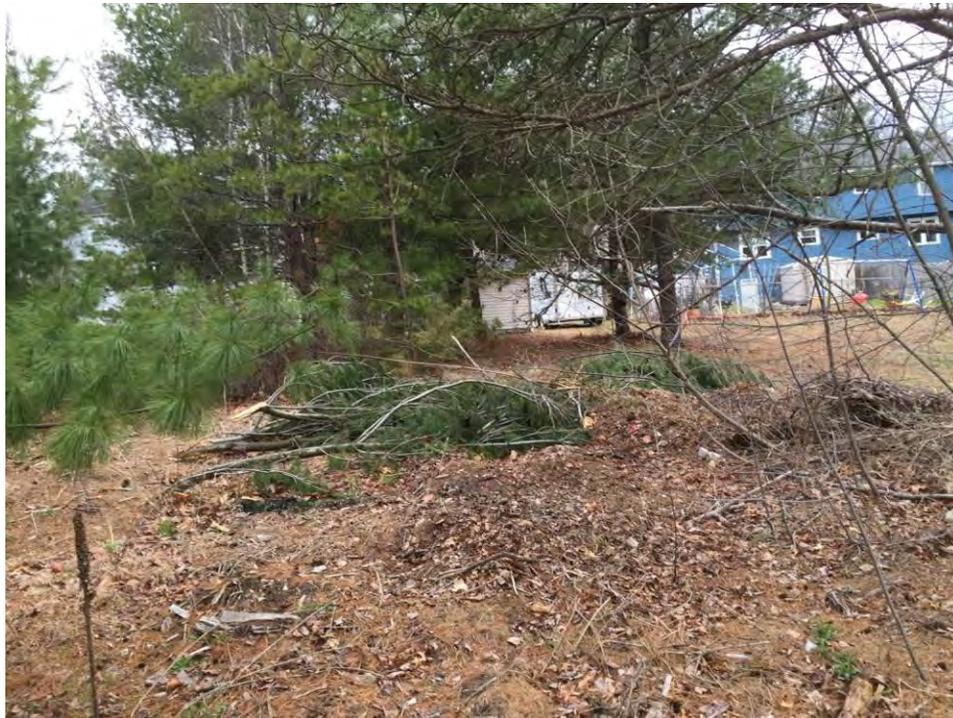
SCENE: View of yard waste from adjacent residences scattered on the 171 Central Street property. Photograph taken facing northwest.

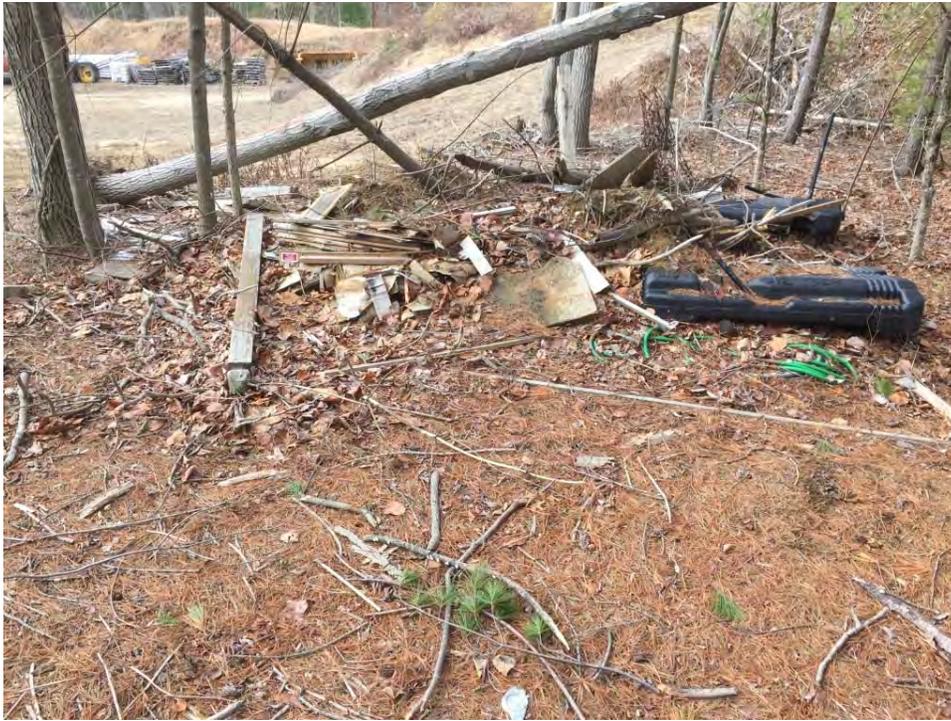
SCENE: View of household waste from adjacent residences scattered on the 171 Central Street property. Photograph taken facing west.

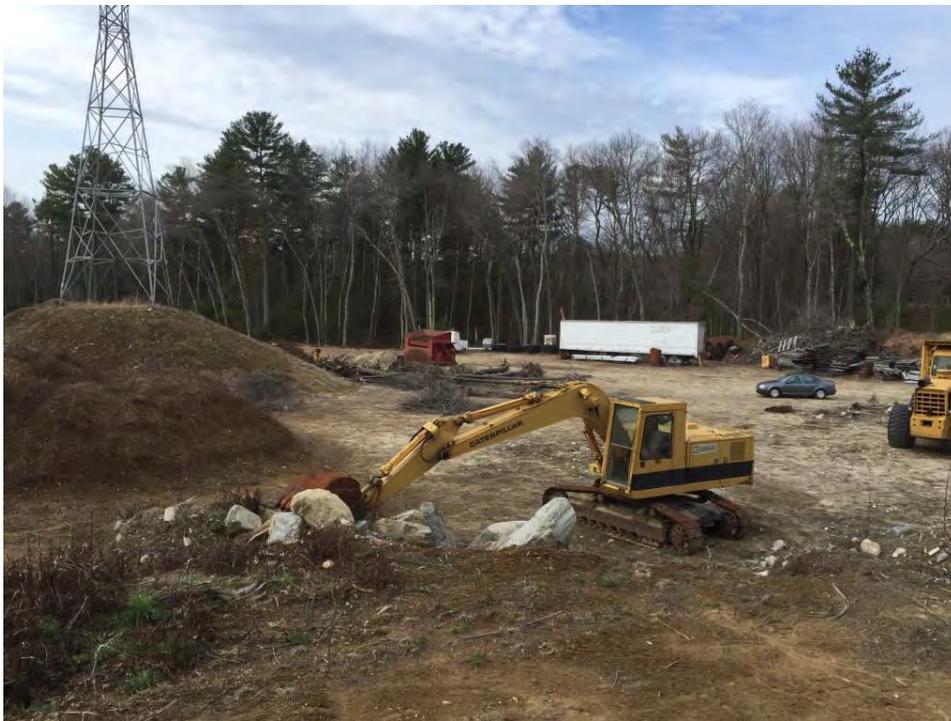
SCENE: View of Central/Operations Area with heavy equipment and sand/gravel piles on the 171 Central Street property. Photograph taken facing southwest.

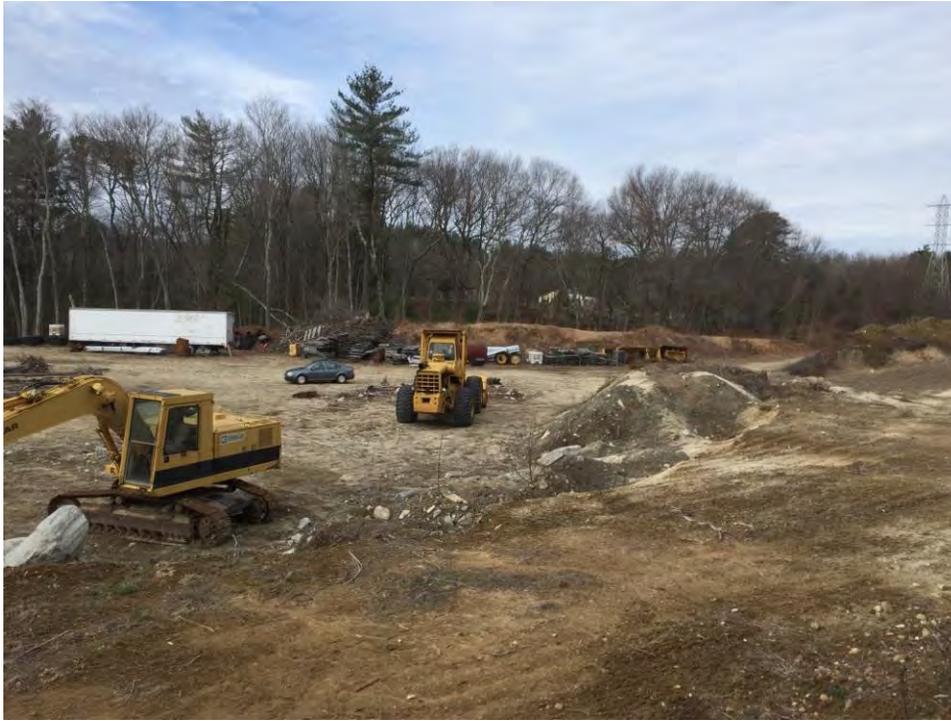
SCENE: View of Central/Operations Area with heavy equipment and sand/gravel piles on the 171 Central Street property. Photograph taken facing west.

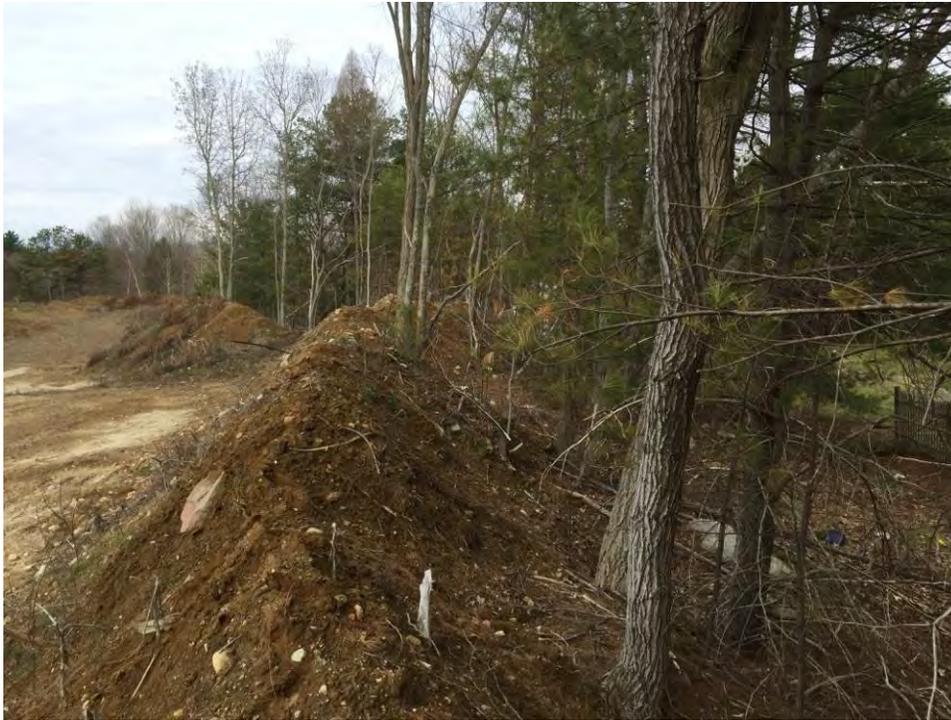
SCENE: View of sand/gravel pile and tree line along the northeastern property boundary on the 171 Central Street property. Photograph taken facing northwest.

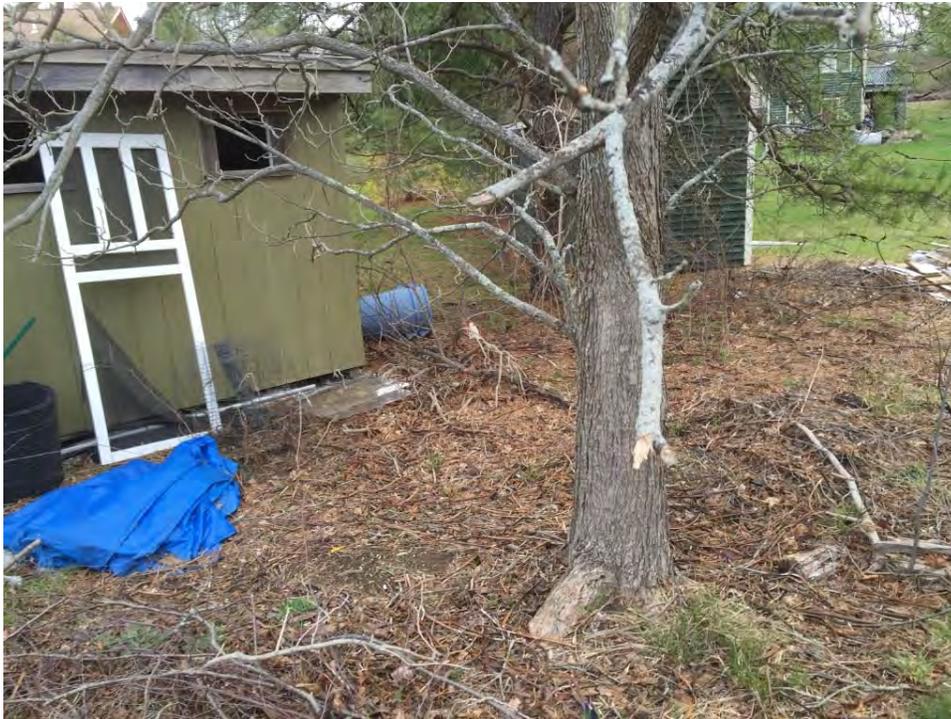
SCENE: View of shed allegedly encroaching over onto the 171 Central Street property. Photograph taken facing north.

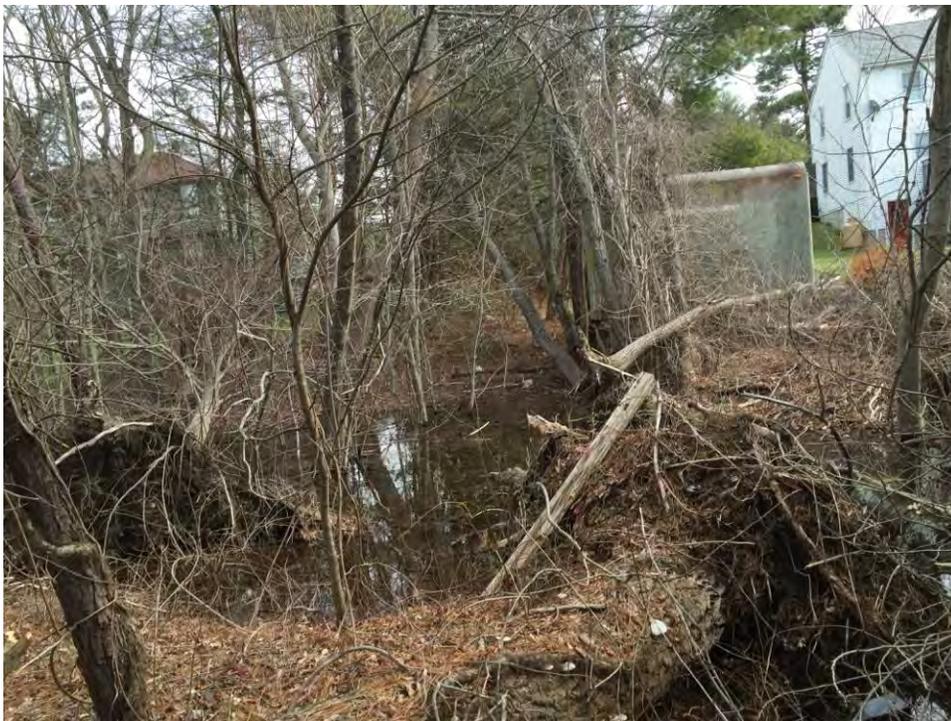
SCENE: View of small ponded area and a concrete drainage culvert located adjacent to the 25 Providence Street property boundary and 171 Central Street property. Photograph taken facing northeast.

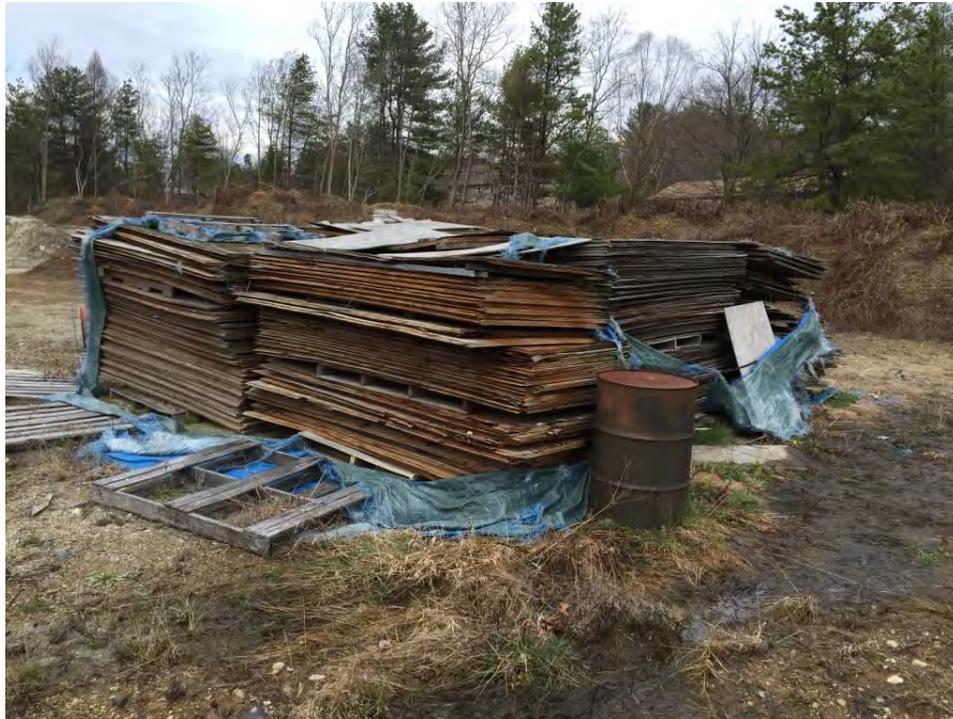
SCENE: View of pallets, wood material, and two 55-gallon drums on the central portion of the 171 Central Street property. Note water flow across property from small ponded area/concrete drainage culvert. Photograph taken facing north.

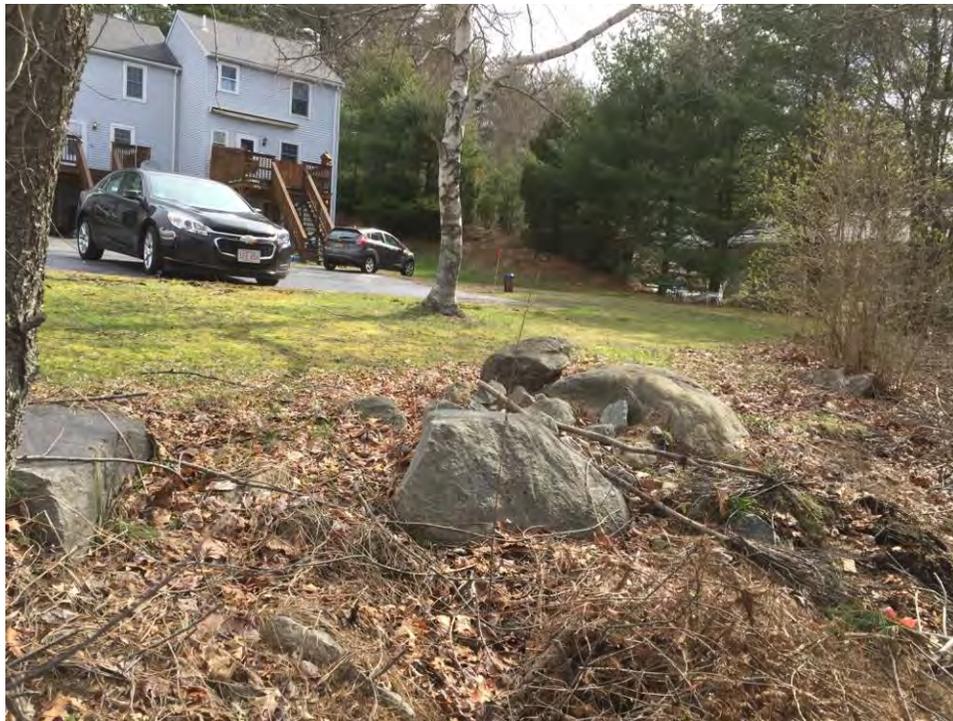
SCENE: View of the 19 Providence Street Property from the 171 Central Street property. Note impacted drinking water well in background. Photograph taken facing east.

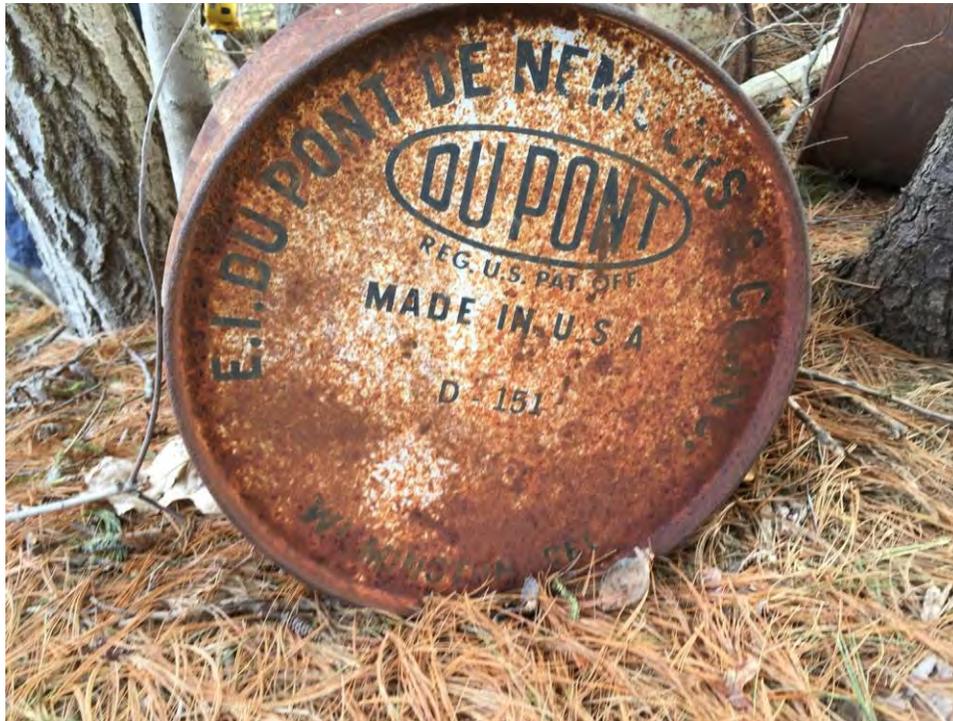
SCENE: View of labeled DuPont 30-gallon drum observed on the property adjacent (southeast) of the 171 Central Street property. Photograph taken facing northeast.

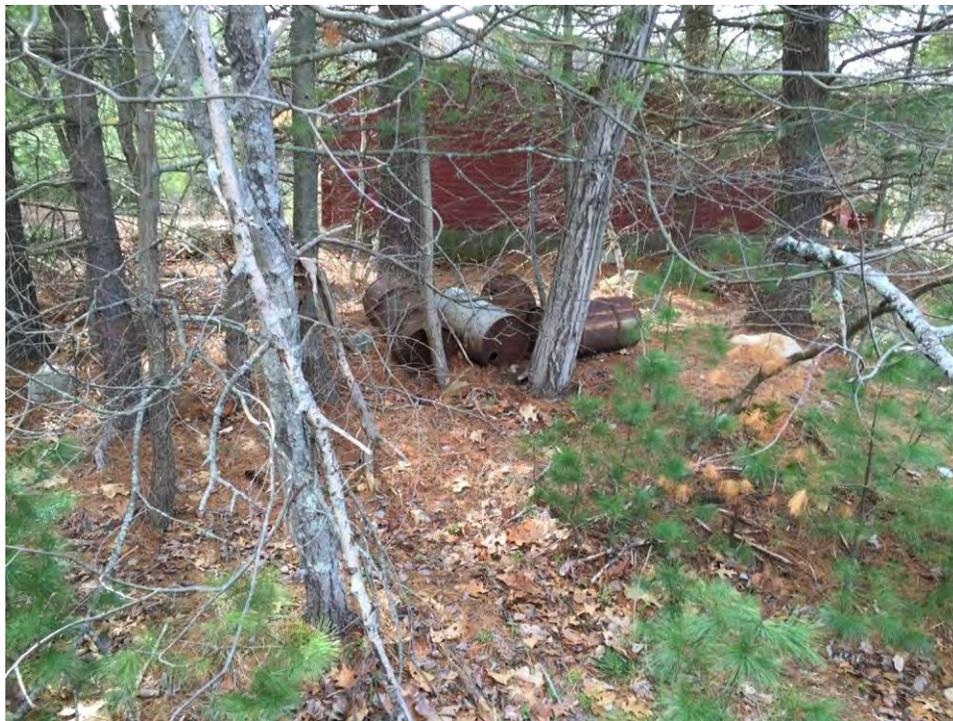
SCENE: View of the four 30-gallon drums observed on the adjacent property (assumed to be 15 Providence Street, Millville, MA or 254 Old Great Road, North Smithfield, RI). Note reddish garage/barn/shed structure in background. Photograph taken facing southeast.

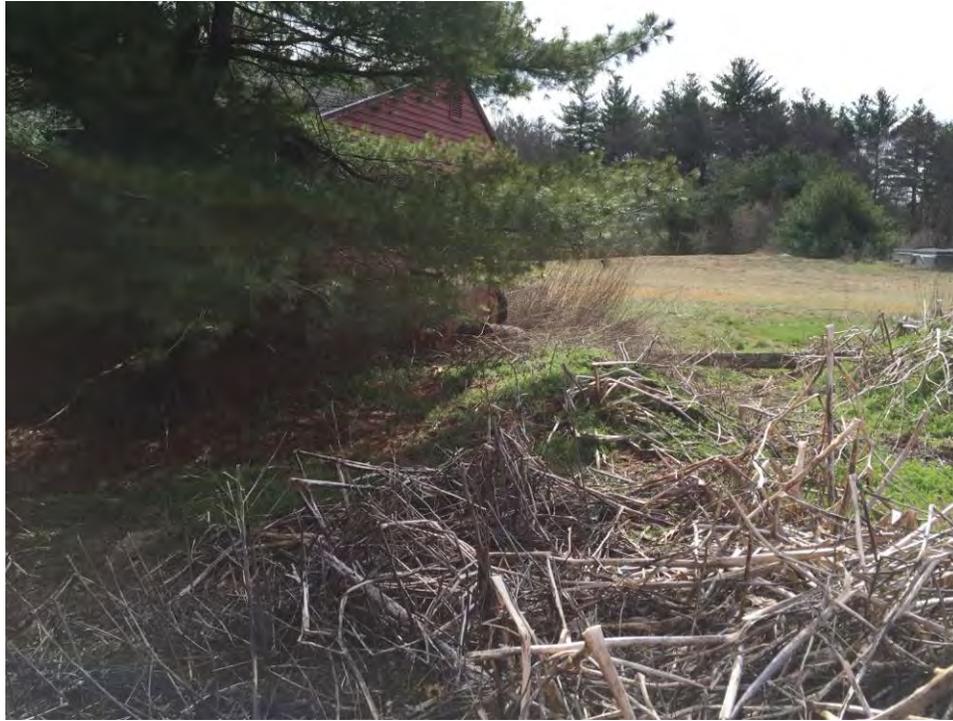
SCENE: View of a least one 55-gallon drum on the adjacent property (assumed to be 15 Providence Street Millville, MA or 254 Old Great Road, North Smithfield, RI). Photograph taken facing east.

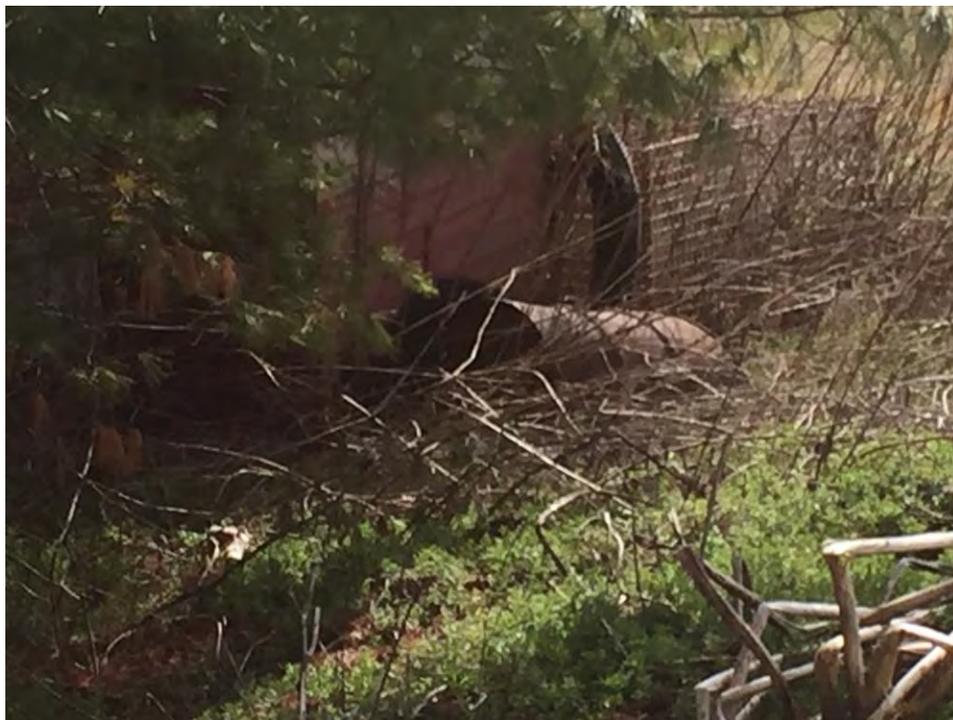
SCENE: Close-up view of the 55-gallon drum on the adjacent property. Note reddish garage/barn/shed structure in background. Photograph taken facing east.

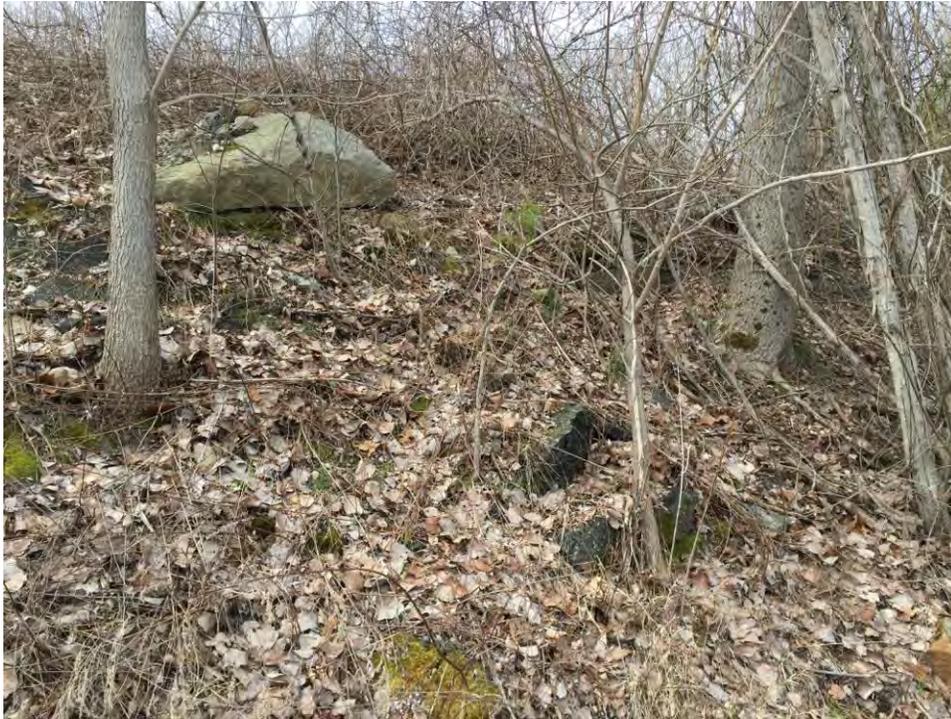
SCENE: View of mixed soil and road construction debris (pieces of asphalt, concrete, lumber, and waste-rock containing blast drill holes) on the southeastern boundary of the 171 Central Street property. Photograph taken facing south.

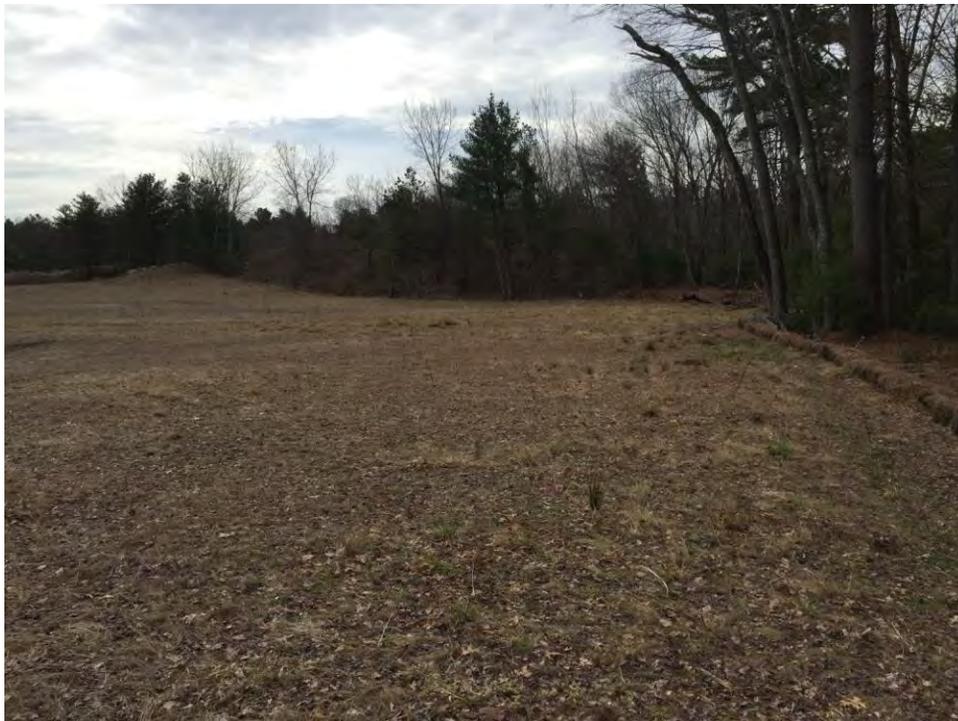
SCENE: View of the open/cleared area within the southeastern portion of the 171 Central Street property, and the wetlands/woodlands to the southwest. Note erosion control to right (west). Photograph taken facing southeast.

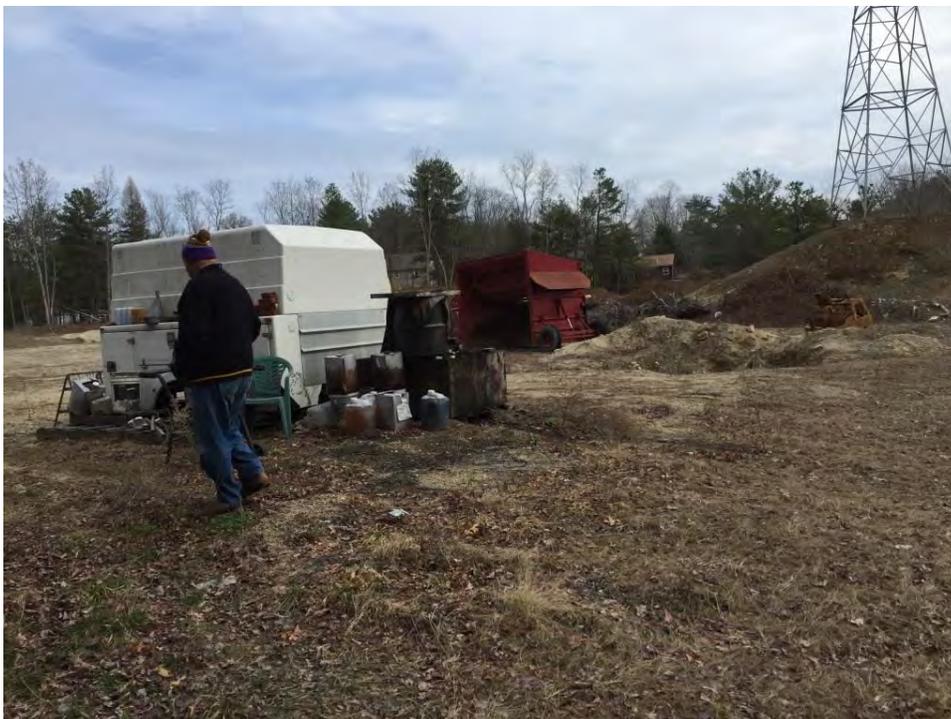
SCENE: View of truck bed storage container, containers of vegetable oil/bio-fuel and portable refueling tank/container on the 171 Central Street property. Note the screener and transmission tower in background. Photograph taken facing northeast.

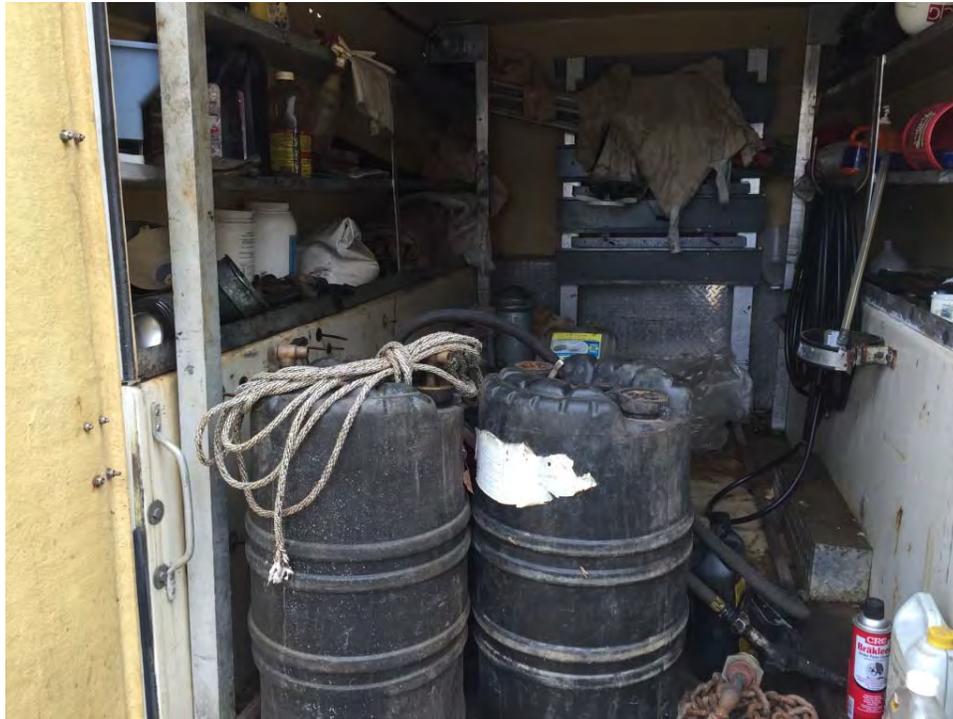
SCENE: View of the inside of the truck bed storage container. Note the containers. Photograph taken facing south.

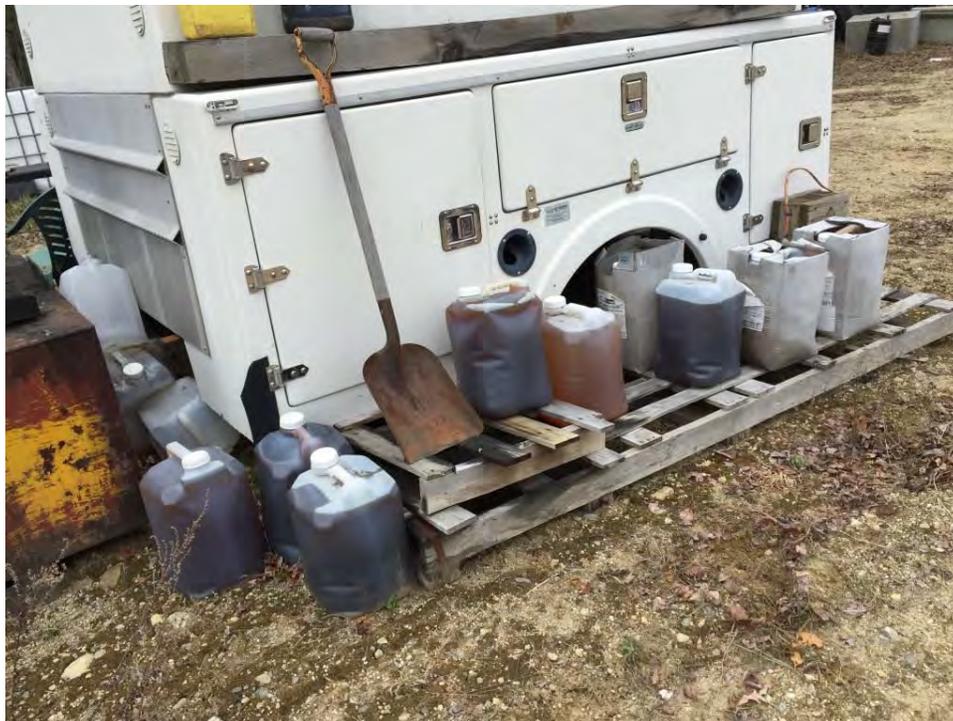
SCENE: View of 5-gallon containers of vegetable oil/bio-fuel outside the truck bed storage container. Note oil staining on pallets. Photograph taken facing northwest.

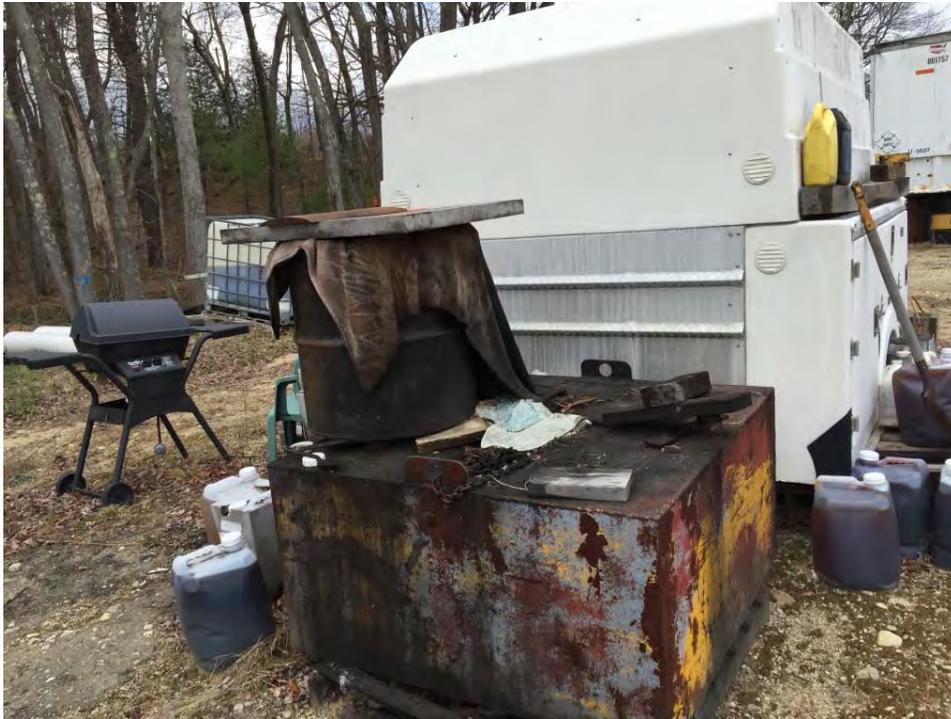
SCENE: View of the truck bed storage container, portable refueling tank/container, and 5-gallon containers on the 171 Central Street property. Photograph taken facing north.

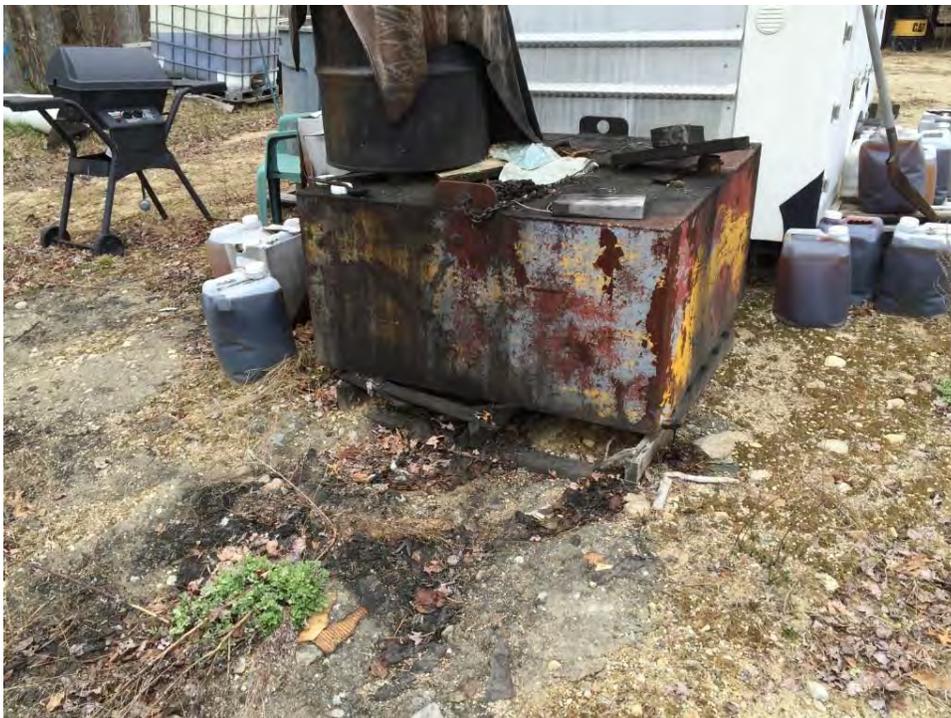
SCENE: View of the portable refueling tank/container on the 171 Central Street property. Note the surface soil staining. Photograph taken facing north.

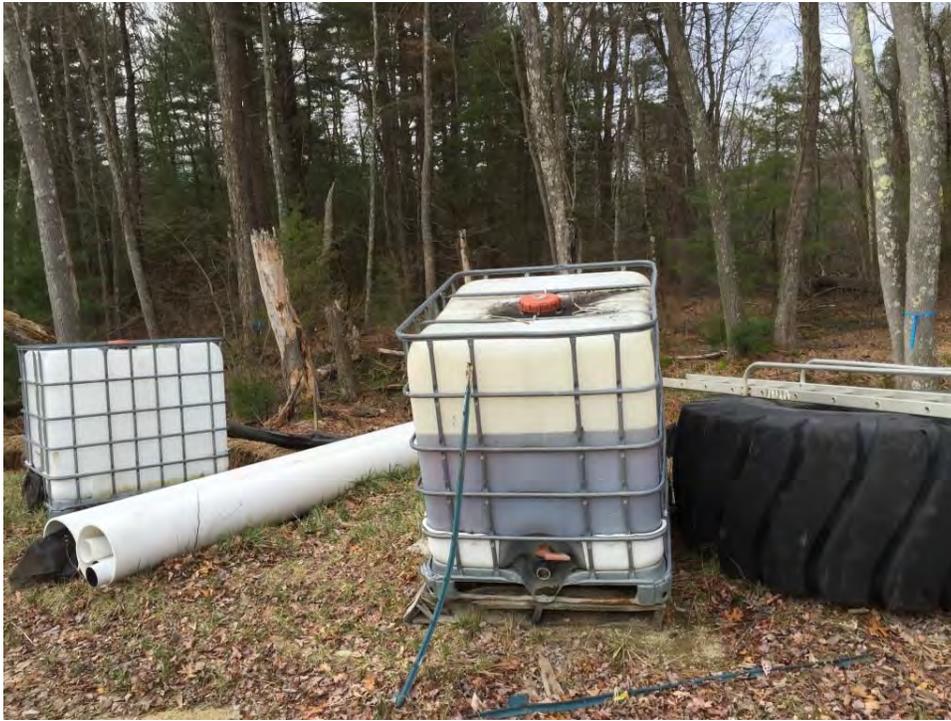
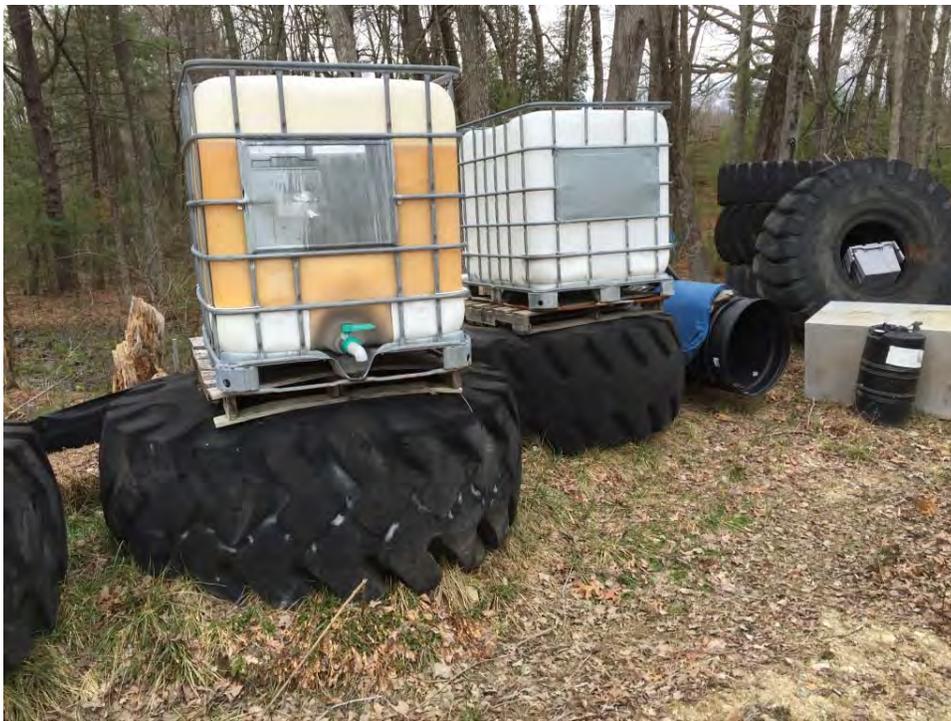
SCENE: View of the 300-gallon totes reportedly containing vegetable oil/bio-fuel. Photograph taken facing west.

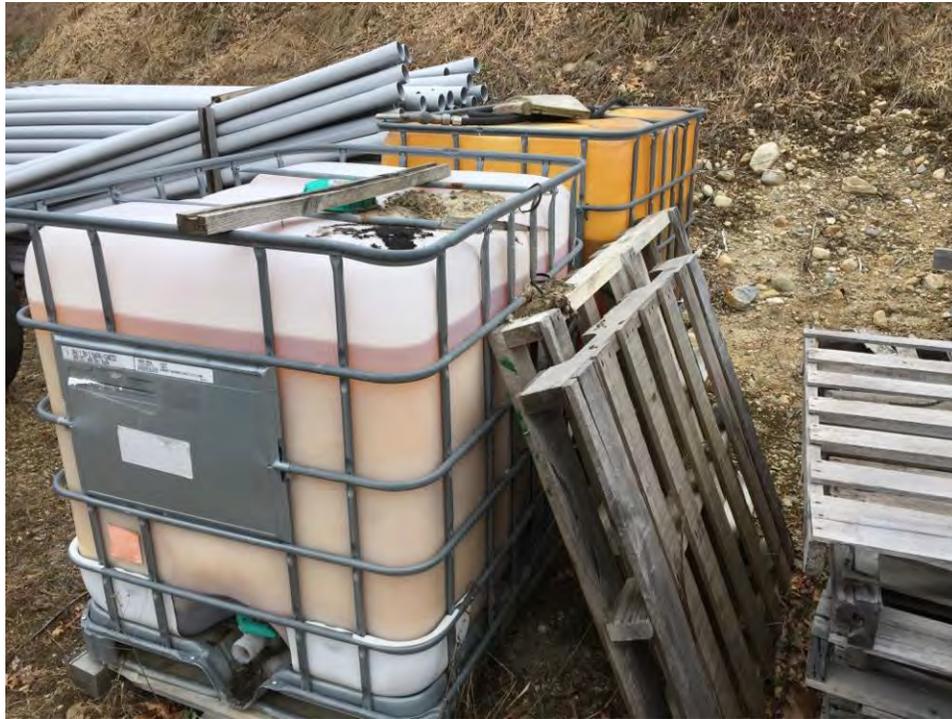
SCENE: View of 300-gallon totes of vegetable oil/bio-fuel, pallets, and piping on the 171 Central Street property. Photograph taken facing southwest.

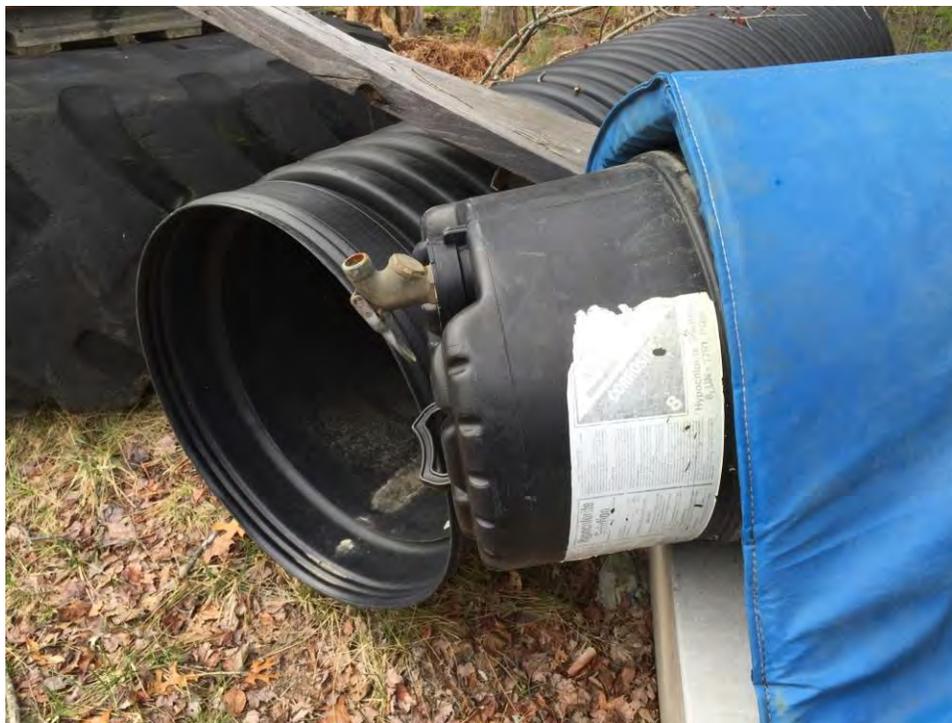
SCENE: View of empty 5-gallon container of hypochlorite solution. Photograph taken facing southwest.
