**FINAL REPORT
FOR
MILLVILLE TCE
PRELIMINARY ASSESSMENT
MILLVILLE, MASSACHUSETTS**

Prepared For:
U.S. Environmental Protection Agency
Region I
Office of Site Remediation and Restoration
5 Post Office Square, Suite 100
Boston, MA 02109-3912

Submitted by:
Weston Solutions, Inc.
Region I
Superfund Technical Assessment and Response Team IV (START)
101 Billerica Avenue, Building 5, Suite 103
North Billerica, Massachusetts 01862
February 2017

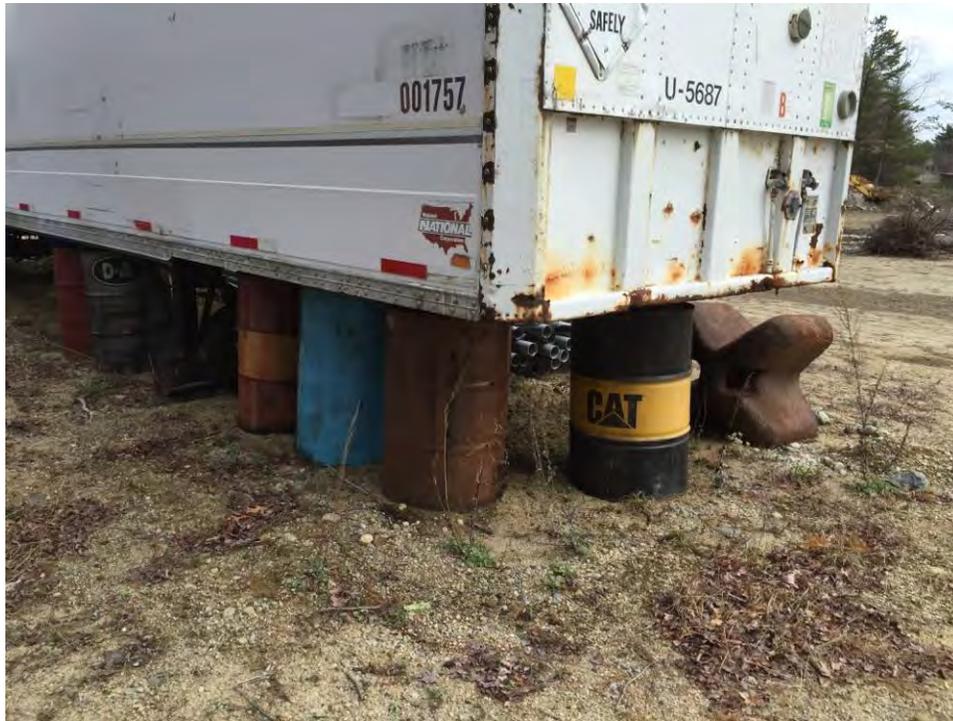
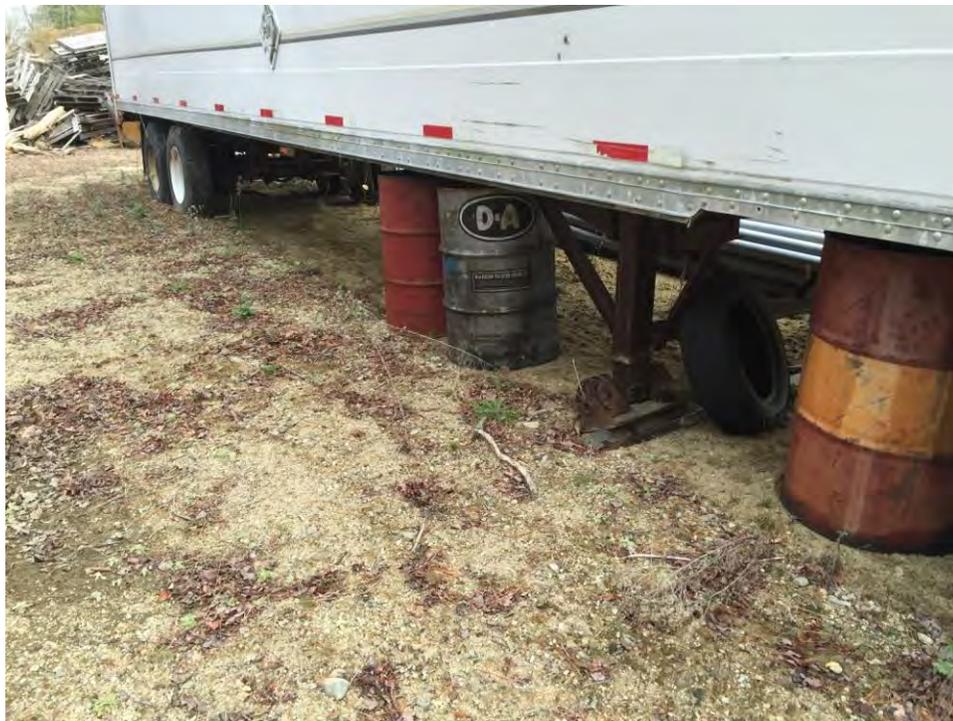
SCENE: View of the six empty 55-gallon drums staged under the storage truck trailer. Photograph taken facing northeast.

SCENE: View of the empty 55-gallon drums staged under the storage truck trailer. Photograph taken facing northeast.

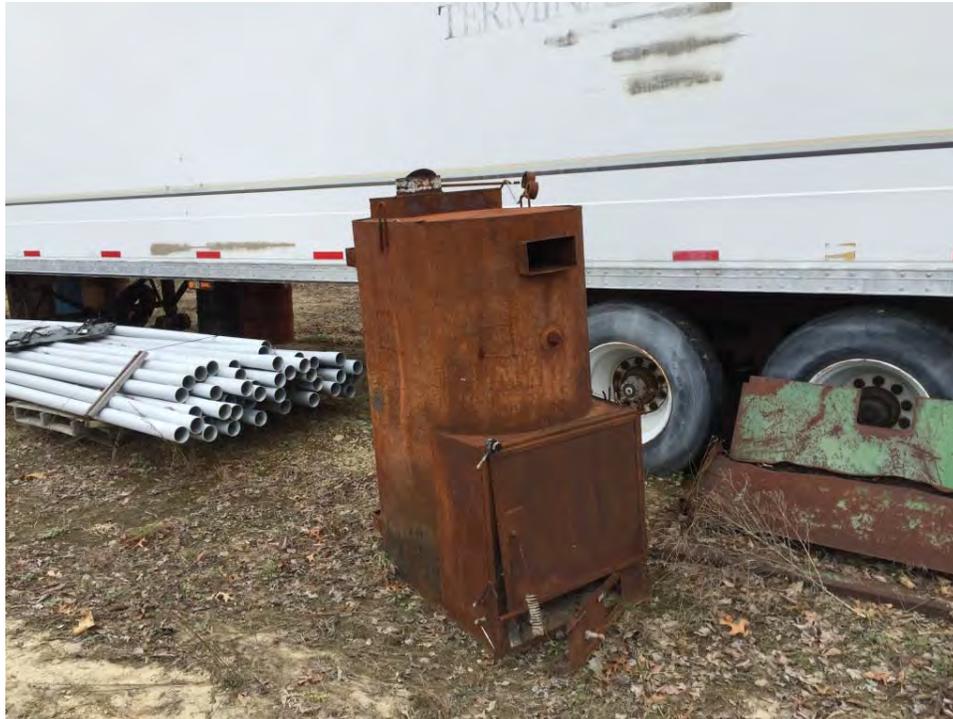
SCENE: View of a furnace along the storage truck trailer on the 171 Central Street property. Photograph taken facing southwest.

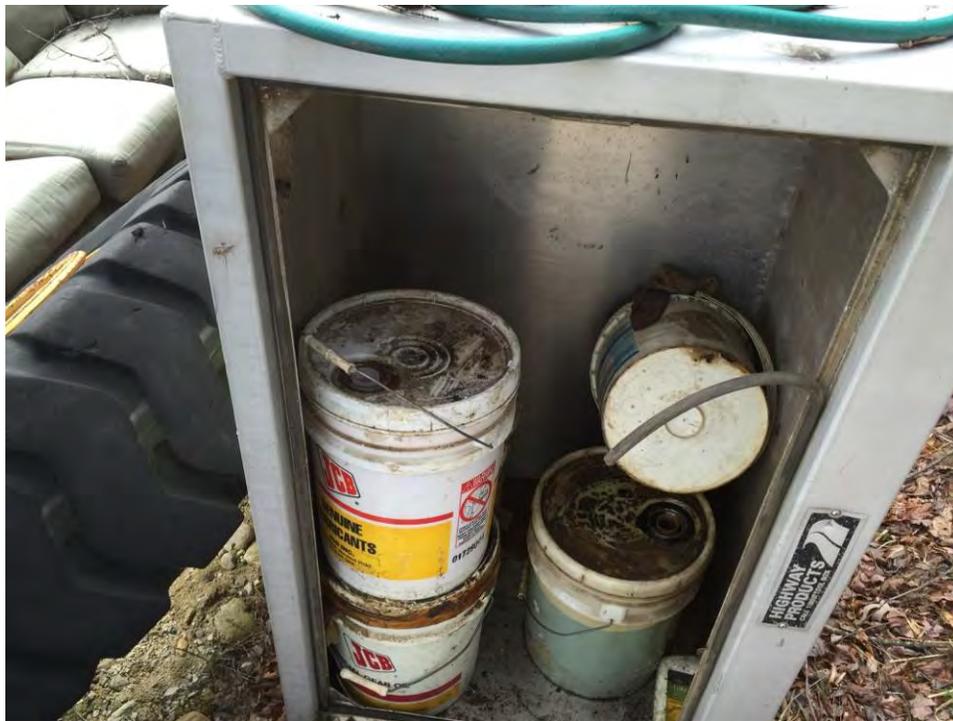
SCENE: View of four (4) 5-gallon containers of oils/lubricants in a small storage box. Photograph taken facing west.

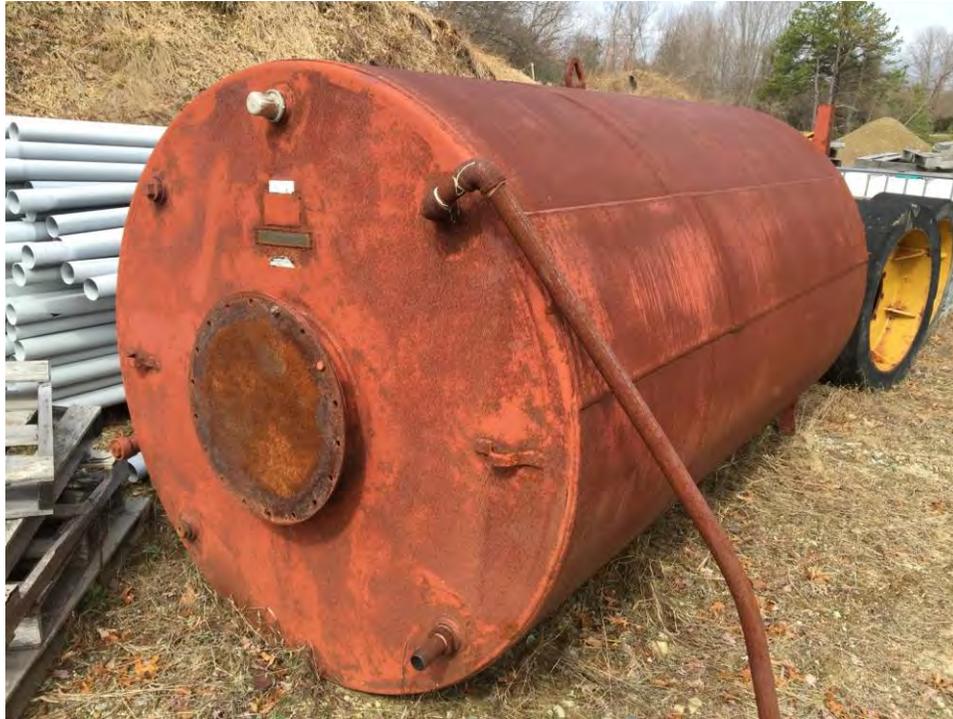
SCENE: View of the estimated 1,000-gallon (empty) Flammable Liquids aboveground storage tank (AST). Photograph taken facing northwest.

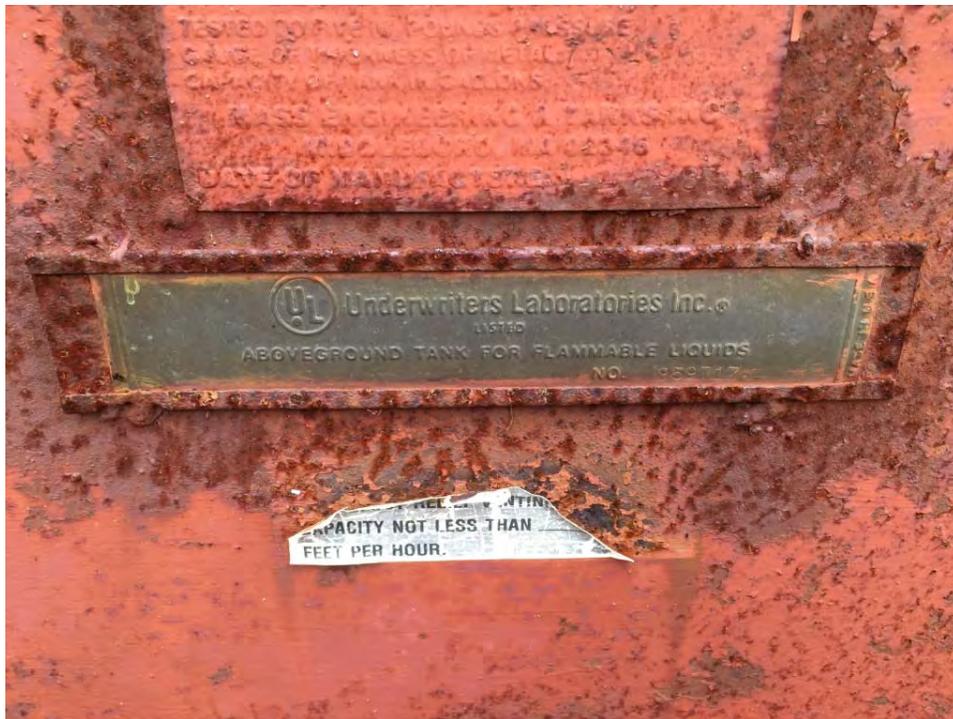
SCENE: View of the estimated 1,000-gallon (empty) Flammable Liquids AST Label. Photograph taken facing north.

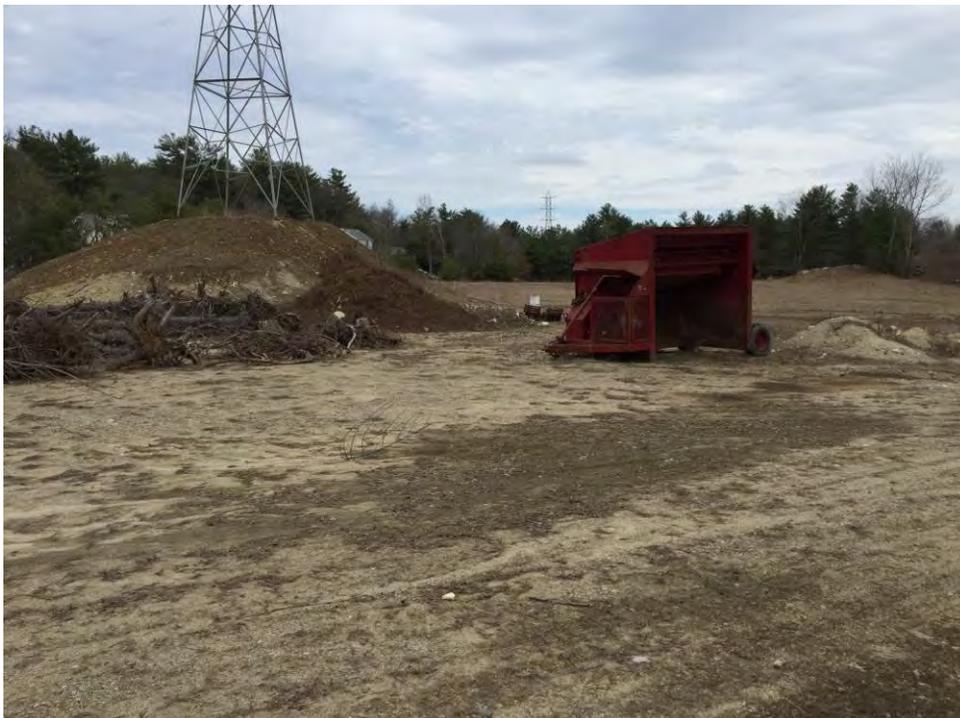
SCENE: View of the screener on the 171 Central Street property. Photograph taken facing east-southeast.

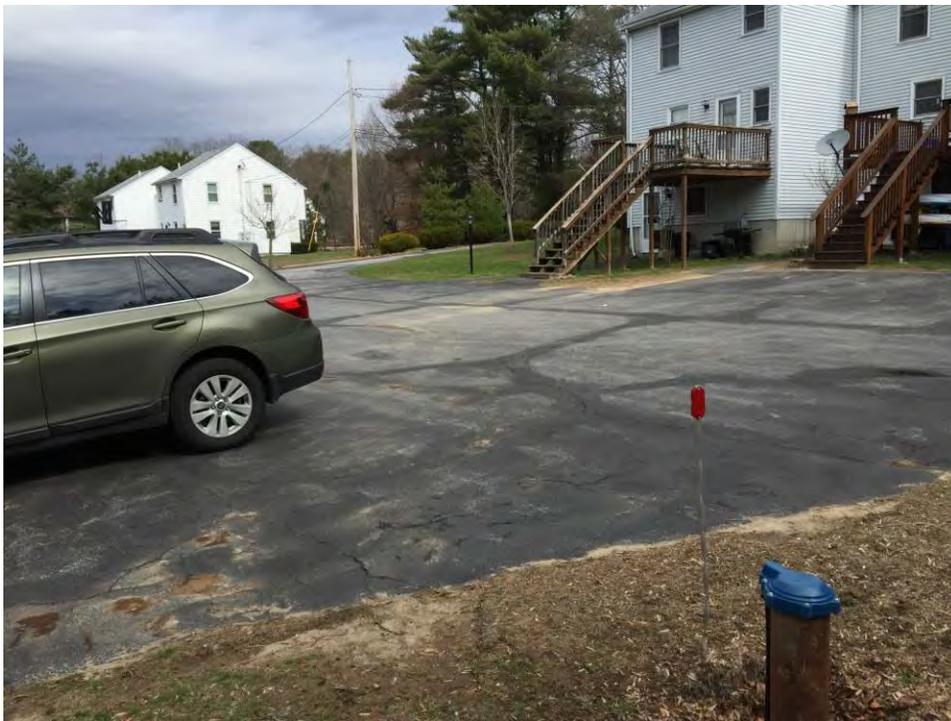
SCENE: View of the drinking water supply well on the 19 Providence Street property. Photograph taken facing north-northwest.

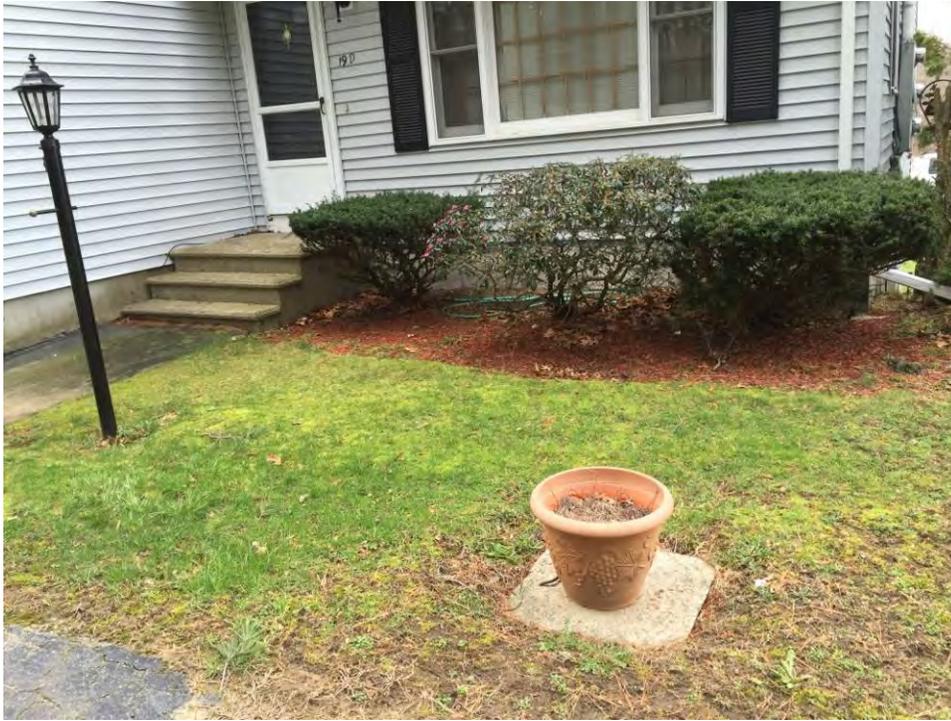
SCENE: View of the septic clean-out location (under flower pot) on the 19 Providence Street property. Photograph taken facing south.

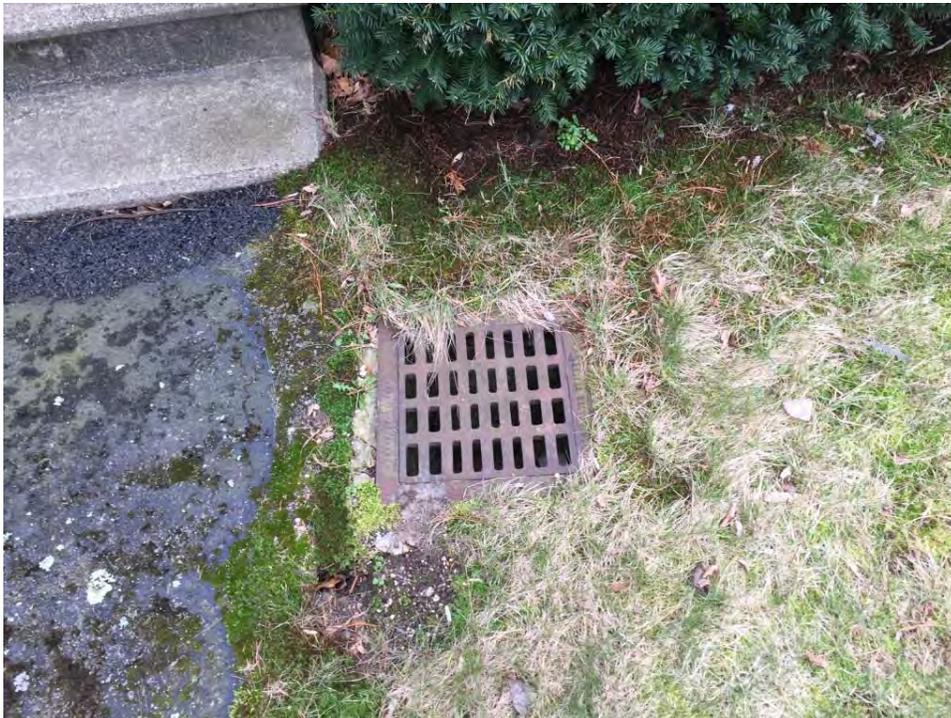
SCENE: View of a storm drain on the 25 Providence Street property. Photograph taken facing south-southwest.

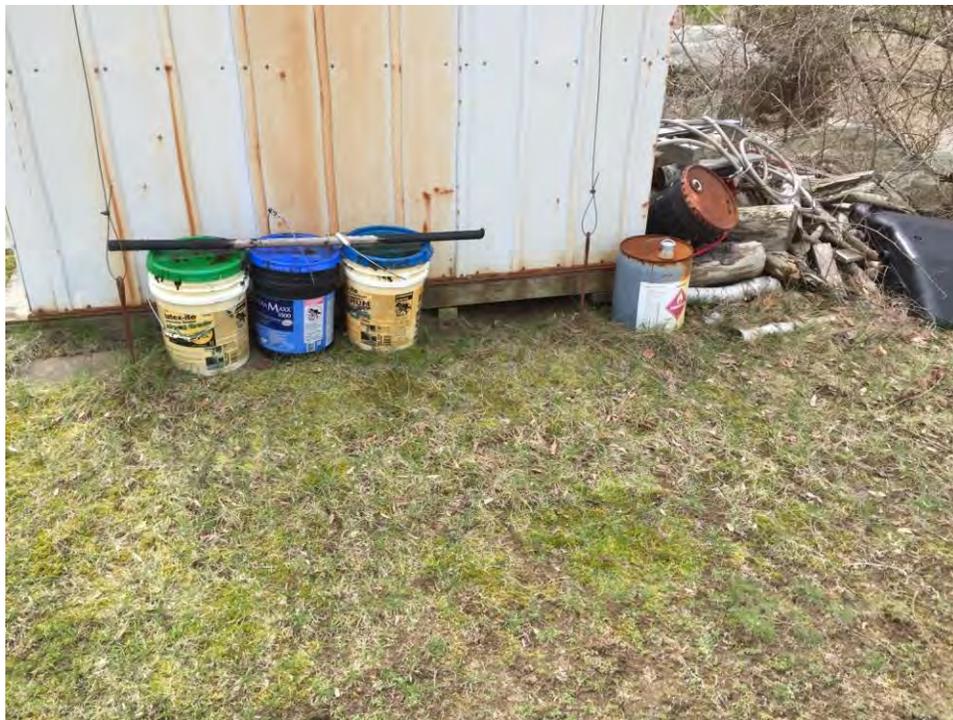
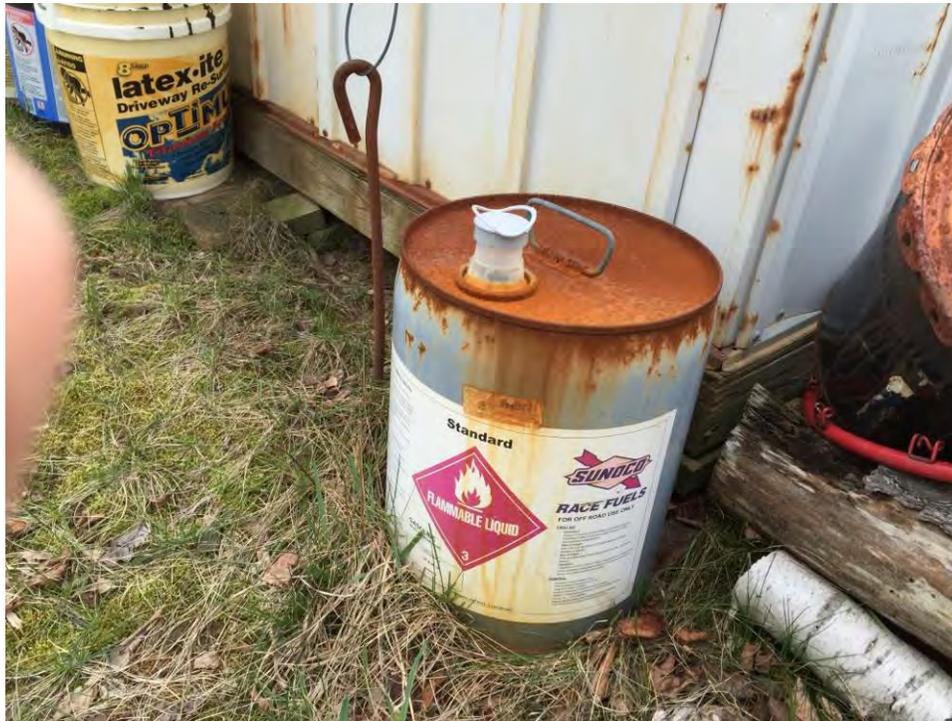
SCENE: View of 5-gallon containers (driveway sealer, racing fuel) outside a shed on the 19 Providence Street property. Photograph taken facing northeast.

SCENE: Close-up view of 5-gallon containers outside a shed on the 19 Providence Street property. Photograph taken facing north-northwest.

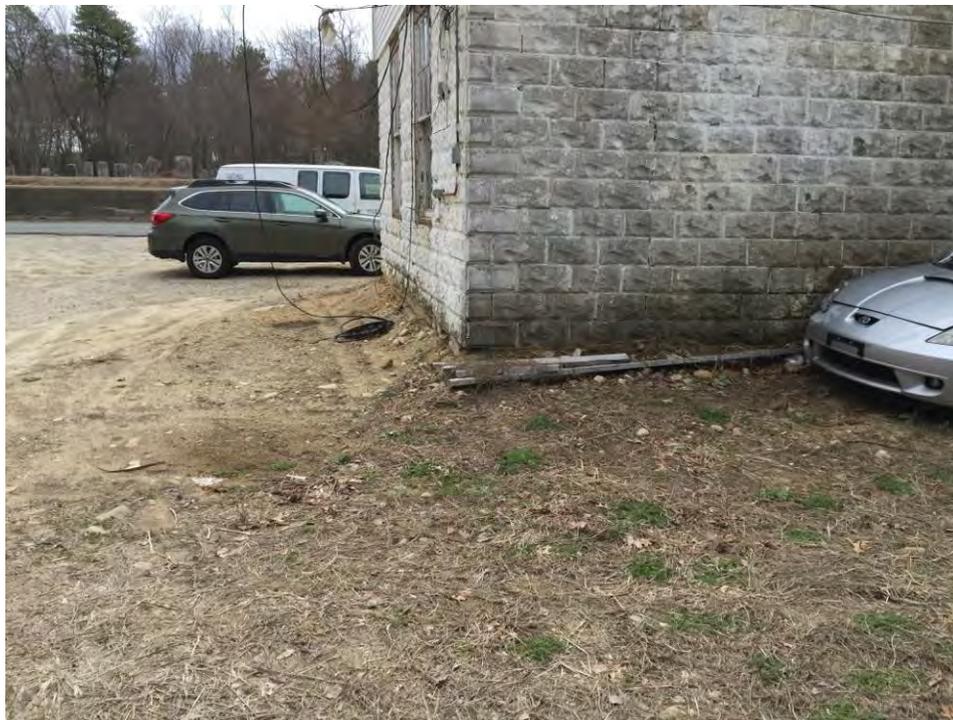
SCENE: View of the north side of building parking lot and an abandoned car on the 190 Central Street property. Note soil staining at edge of vegetation/grass. Photograph taken facing southeast.

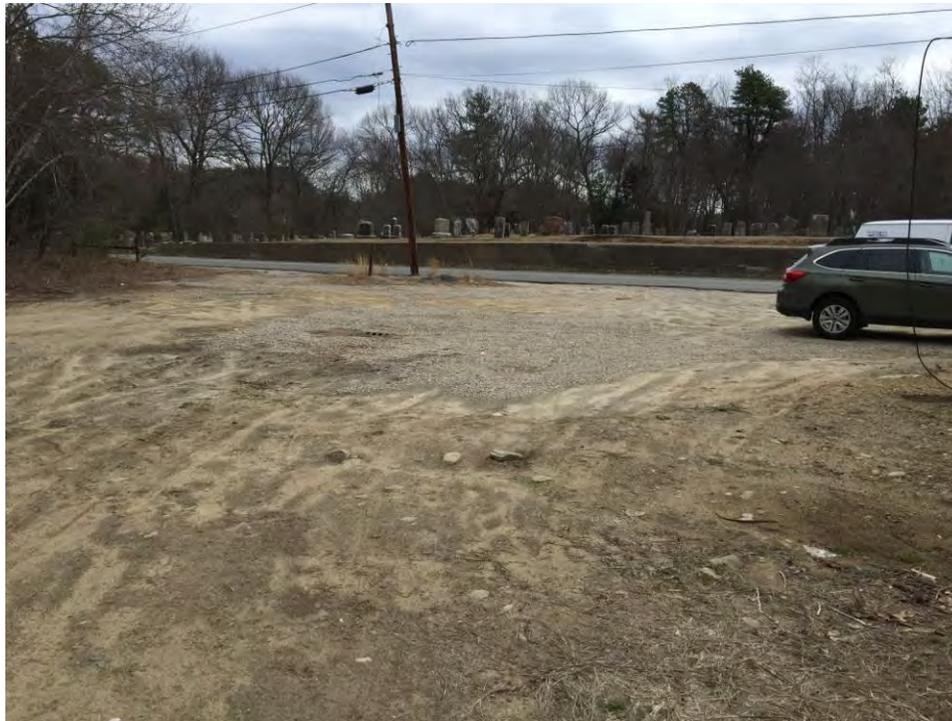
SCENE: View of the north gravel parking lot and former underground storage tank (UST) Grave area (AOC-1) on the 190 Central Street property. Photograph taken facing east.

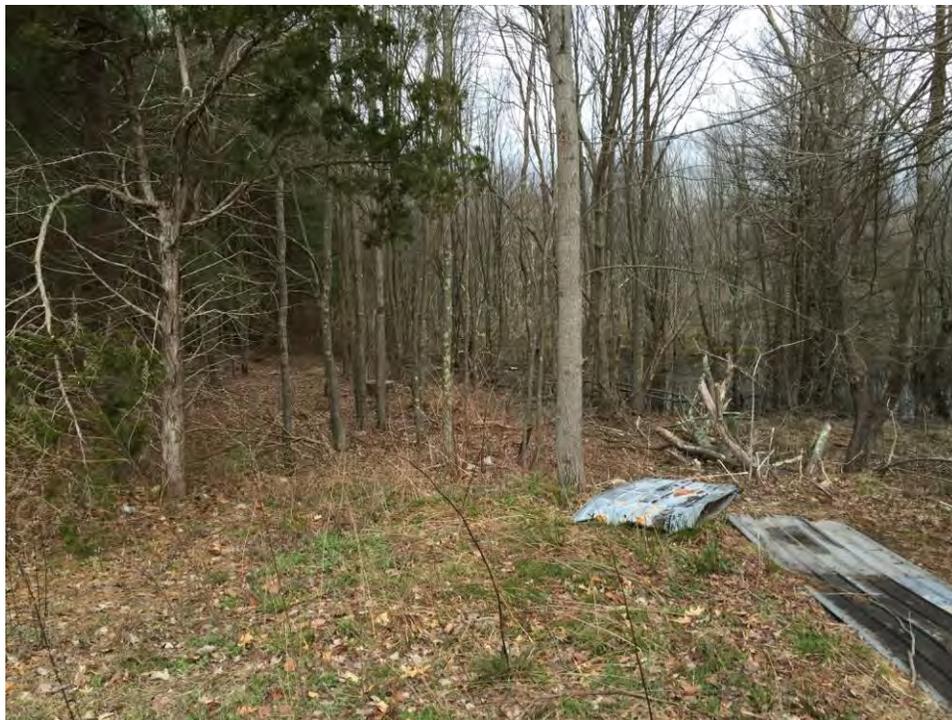
SCENE: View of the northwestern portion of the 190 Central Street property and potable supply well area on adjacent property. Photograph taken facing north-northwest.

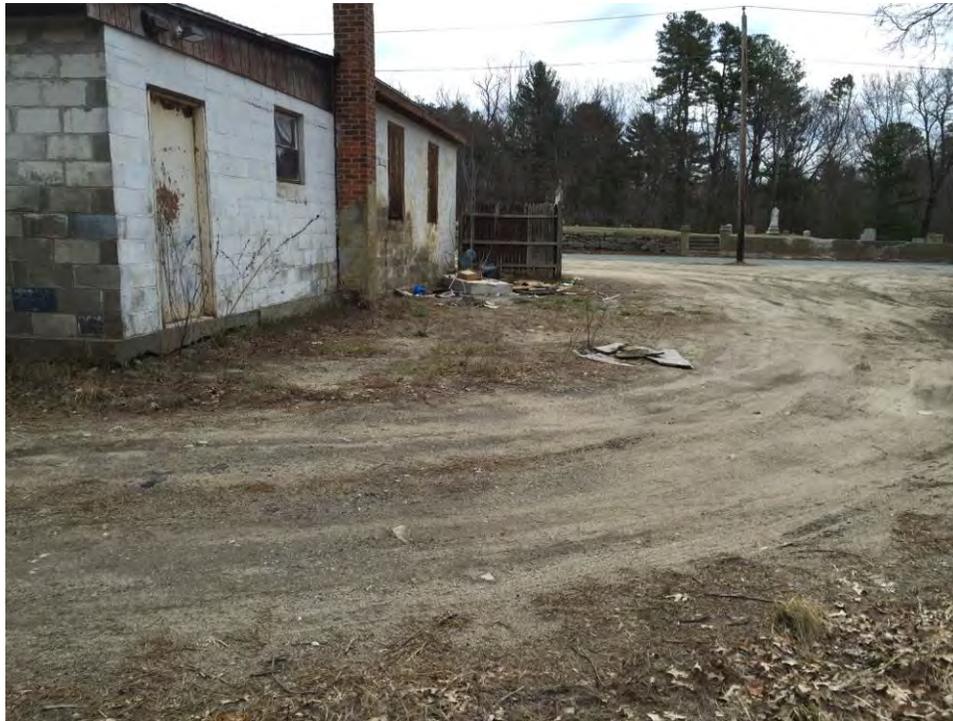
SCENE: View of the southern side of building and dirt parking lot on 190 Central Street property. Location of the Former Surficial Oil Stain area (AOC-5) and the Former Outdoor Service pit (AOC-3). Photograph taken facing east.

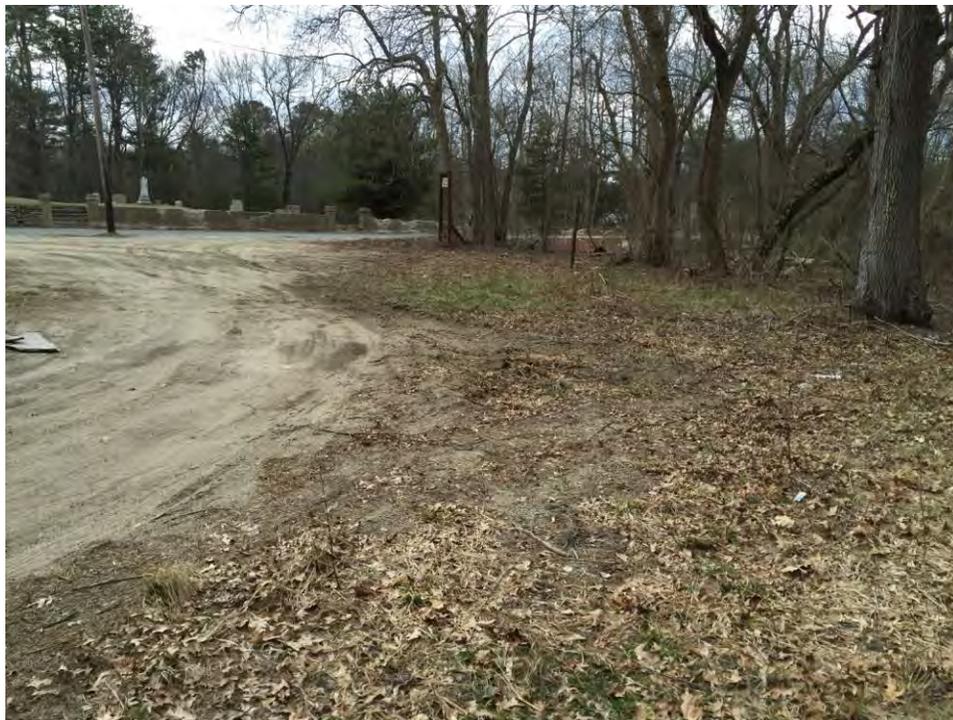
SCENE: View of the southern portion of the 190 Central Street property. Location of the Former Outdoor Service pit (AOC-3). Photograph taken facing southeast.

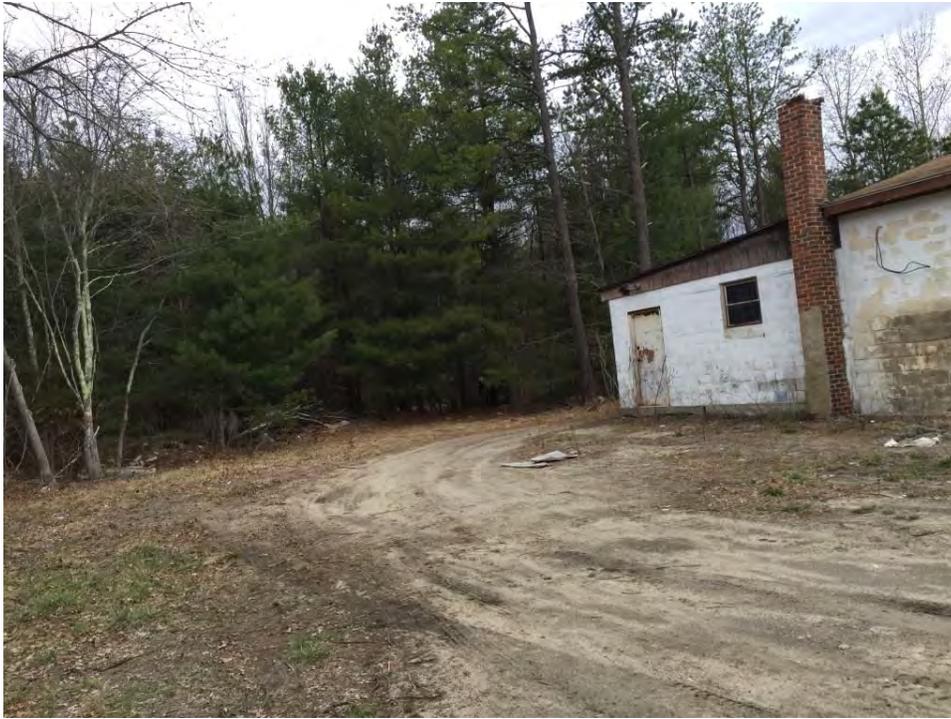
SCENE: View of the southern portion of the 190 Central Street property building. Background is location of the Former Waste Oil Storage Shed (AOC-4) (removed). Photograph taken facing northwest.

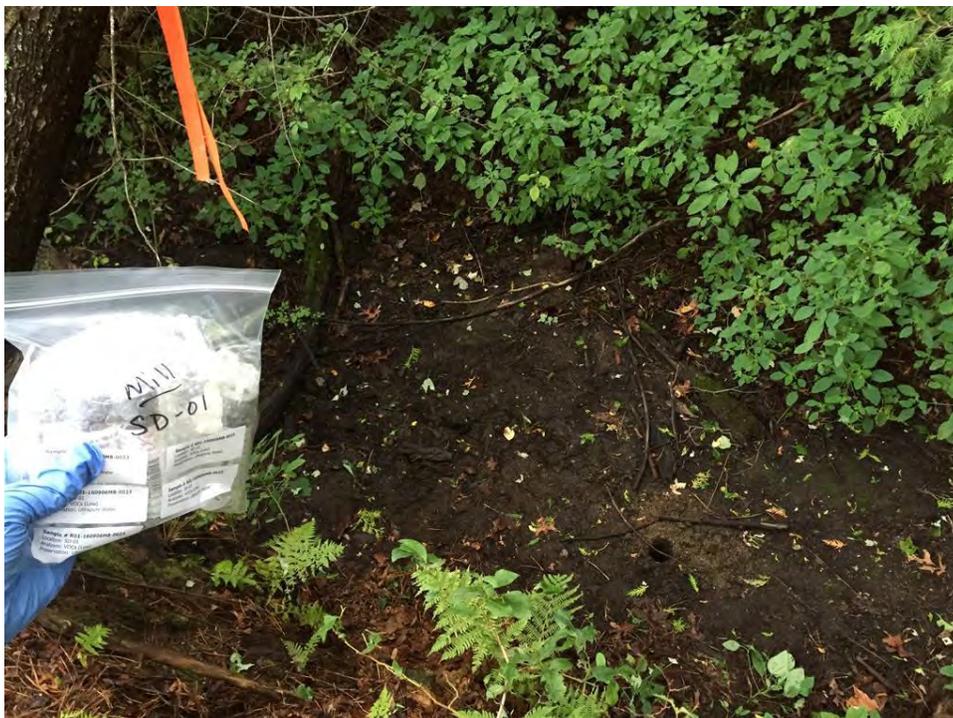
SCENE: View of sediment sample location SD-01 within unnamed stream bed. Photograph taken facing southeast.

As part of the Millville TCE PA, START personnel collected sediment samples associated with the Millville TCE site to determine if the SWP had been impacted by hazardous substances potentially associated with on-site source areas. On 6 September 2016, START personnel collected nine sediment samples (SD-01 through SD-09) from eight locations on the Louis Iarussi (171 Central Street) property (see Attachment A, Figure 8). Six sediment samples (SD-01 through SD-06) were collected from the unnamed stream and ponded wetland areas flowing across the southwestern portion of the 171 Central Street (Louis Iarussi) property. Three of the samples (SD-07 through SD-09) were collected from the north-central portion of the 171 Central Street (Louis Iarussi) property from the small ponded water body, adjacent to a concrete drainage culvert and bordering the 25 Providence Street property. Sediment sample SD-01 was collected as a background sample from the most upstream portion of the unnamed stream. The nine sediment samples were submitted to the EPA OEME NERL laboratory for VOC analysis only [1].

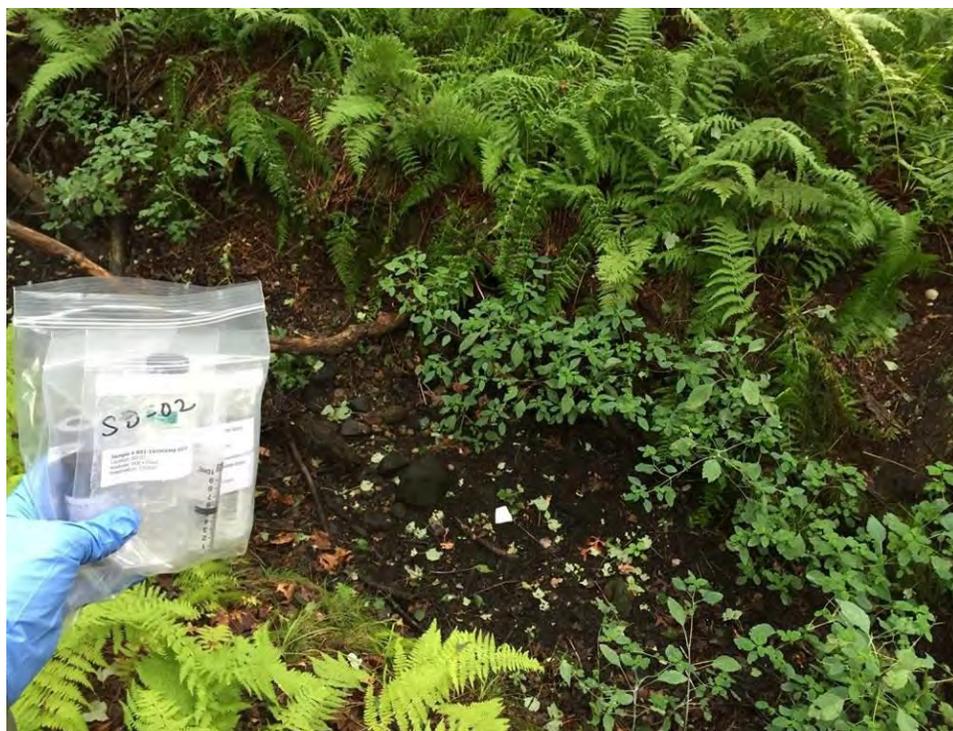
SCENE: View of sediment sample location SD-02 within unnamed stream bed. Photograph taken facing southwest.

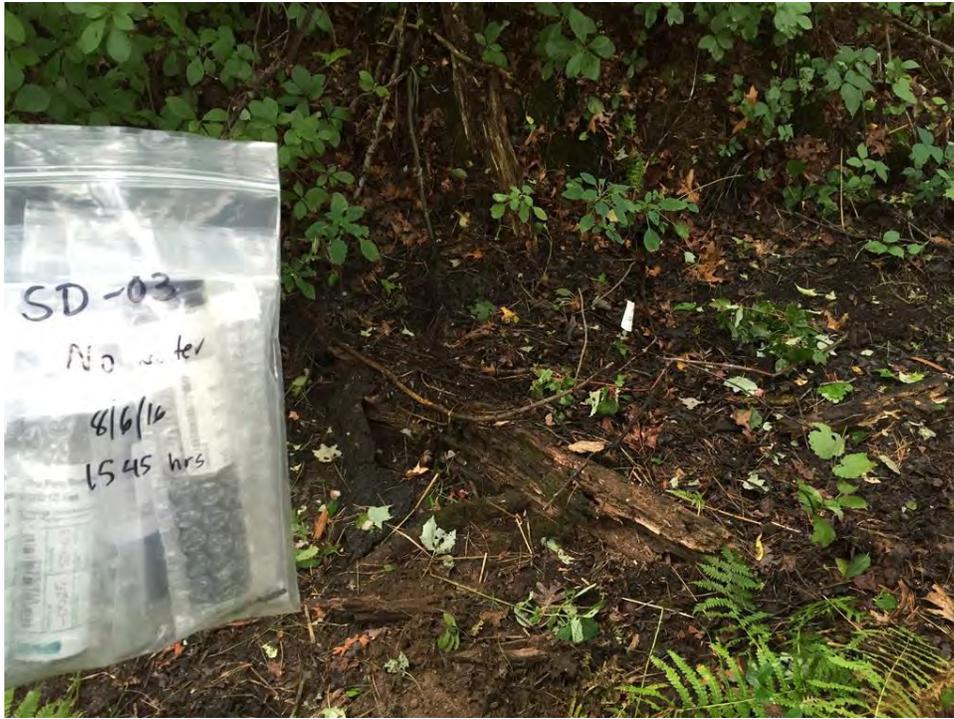
SCENE: View of sediment sample location SD-03 within unnamed stream bed. Photograph taken facing southwest.

SD-03	Grab sediment sample collected from west-central portion of property from the unnamed stream as it flows toward the pond, to determine the presence of hazardous substances. 42.014722296 North Latitude 71.58114143 West Longitude	0-12	0	R01-160906MB-0025	9/7/2016 15:45	VOCs	Sample was collected using a hand auger at depth > 1 ft. Material described as dark brown, fine-to-medium SAND and SILT, little coarse gravel, trace organics (leaf debris). No water quality measurements were taken at this location due to lack of water. PID = 0.0 ppm.
SD-04	Grab sediment sample collected from southwestern portion of property from wetland along pond, to determine the presence of hazardous substances. 42.01413642 North Latitude 71.581328965 West Longitude	0-12	0	R01-160906MB-0026	9/8/2016 15:40	VOCs	Sample was collected using a hand auger. Material described as wet, dark brown, fine-to-medium SAND and SILT, little coarse gravel, trace organics (leaf debris). No water quality measurements were taken at this location due to lack of water. PID = 0.0 ppm.

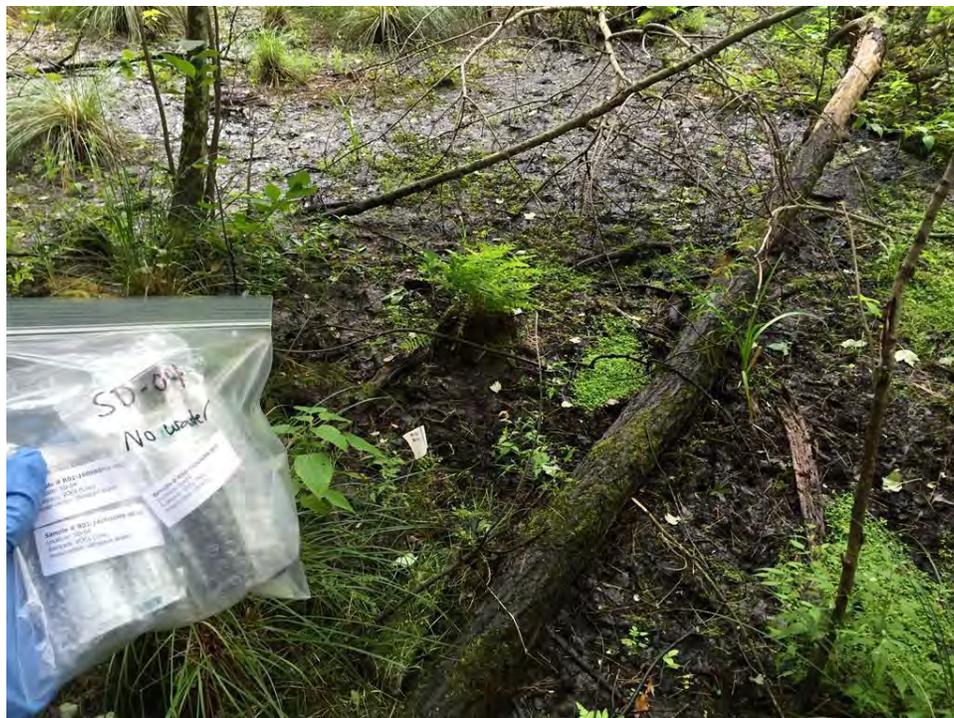
SCENE: View of sediment sample location SD-04 within wetland along pond. Photograph taken facing west.

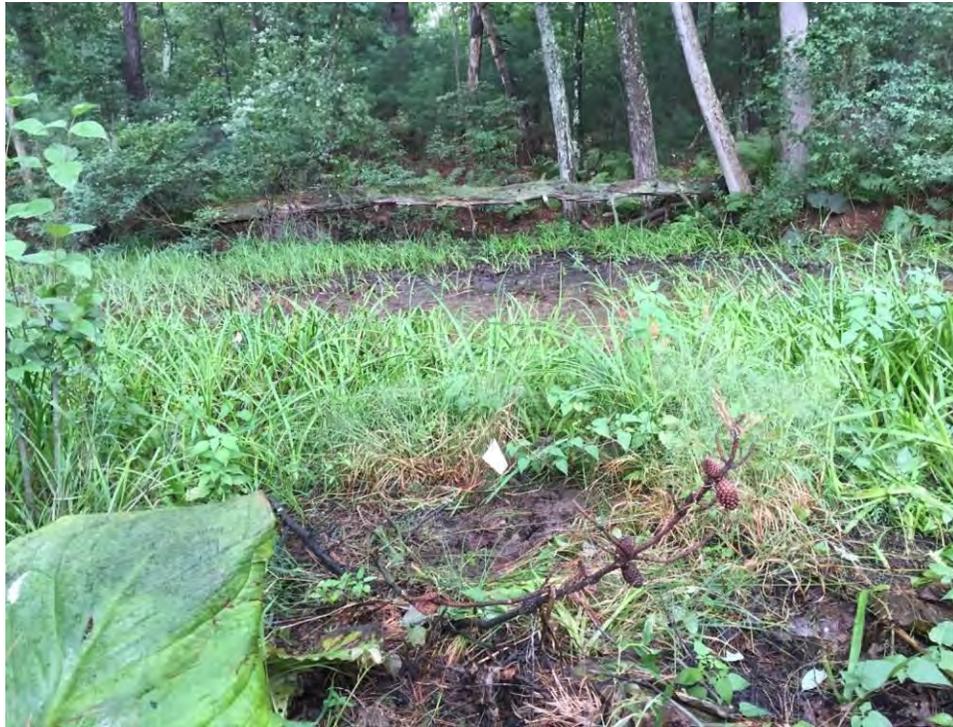
SCENE: View of sediment sample location SD-05 within wetland along unnamed stream. Photograph taken facing west.
DATE: 6 September 2016 **TIME:** 1550 hours
PHOTOGRAPHER: S. Evarts **CAMERA:** iPhone 6

Station Location	Location Description/Rationale	Sample Depth* (inches)	Water Depth (inches)	COC Sample No.	Date and Time (hours)	Analysis	Sample Description
MATRIX: Sediment							
SD-05	Grab sediment sample collected from south-central portion of property from wetland along the unnamed stream downstream of the operational area and upstream of the property line, to determine the presence of hazardous substances. 42.0139719 North Latitude 71.580454888 West Longitude	0-12	6	R01-160906MB-0027	9/9/2016 15:45	VOCs	Sample was collected using a hand auger. Material described as saturated, dark brown, fine-to-medium SAND and SILT, little coarse gravel, trace organics (leaf debris). Specific conductance ($\mu\text{S}/\text{cm}$) = 92.2; Temp. ($^{\circ}\text{C}$) = 19.0; Turbidity (NTU) = 40.1; pH = 6.55; PID = 0.0 ppm.
SD-06	Grab sediment sample collected from central portion of property from the unnamed stream downstream/adjacent to the operational area, to determine the presence of hazardous substances. 42.01428741 North Latitude 71.580988731 West Longitude	0-12	0	R01-160906MB-0028	9/10/2016 1600	VOCs	Sample was collected using a hand auger. Material described as wet, dark brown, fine-to-medium SAND and SILT, little coarse gravel, trace organics (leaf debris). No water quality measurements were taken at this location due to lack of water. PID = 0.0 ppm.

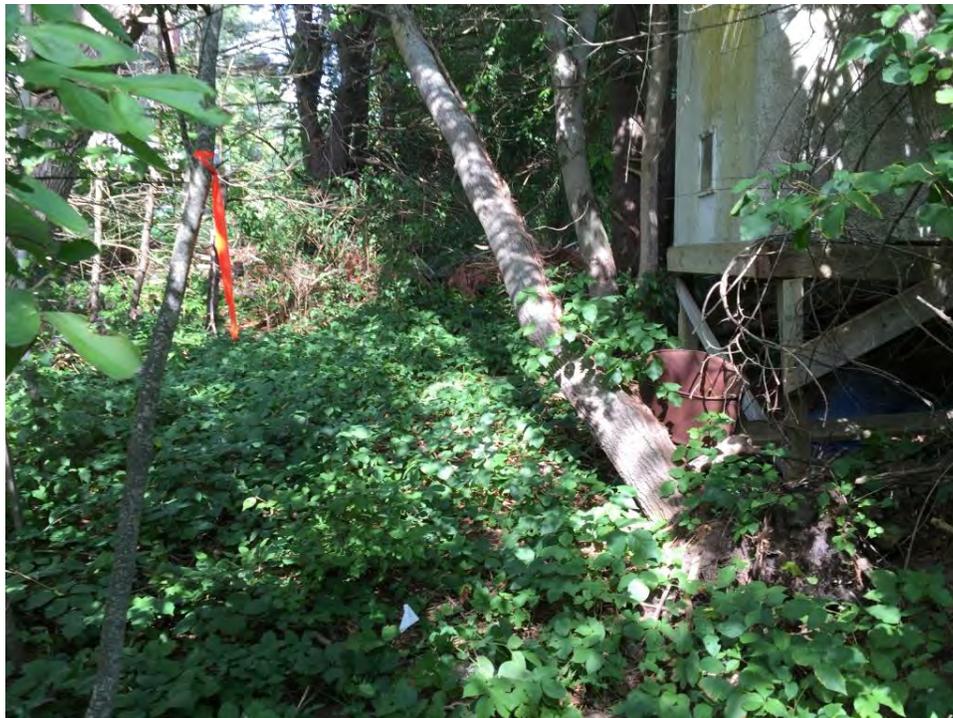
SCENE: View of sediment sample SD-07 collected from small ponded water body, adjacent to a concrete drainage culvert and the 25 Providence Street property. Note rusted 55-gallon drum to right. Photograph taken facing north.

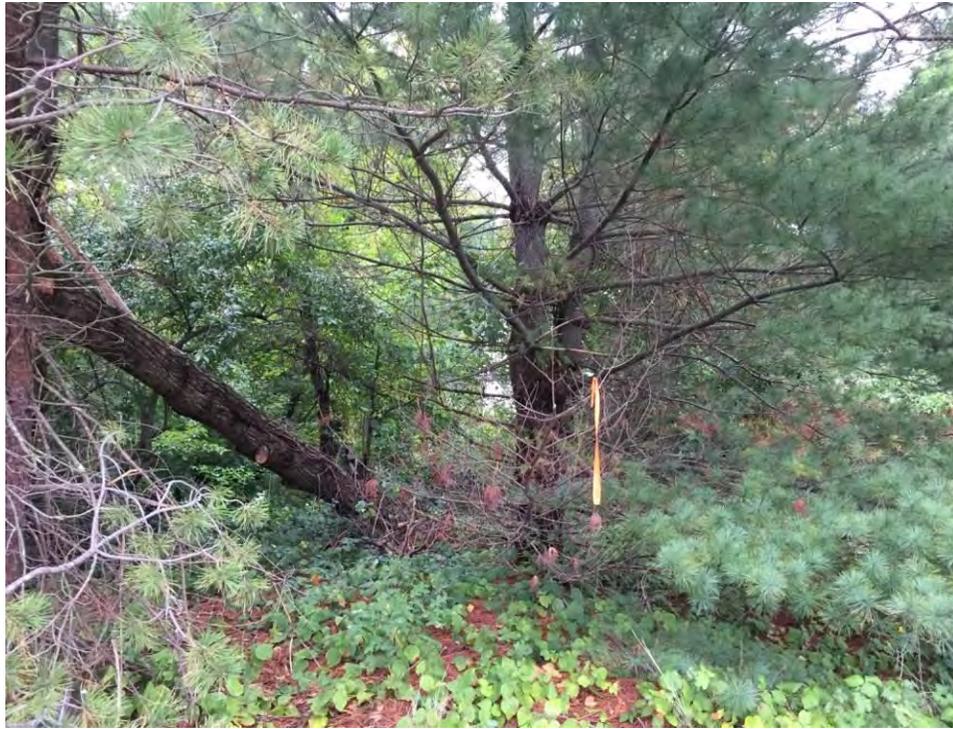
SCENE: View of sediment sample location SD-08/SD-09 collected from small ponded water body, adjacent to a concrete drainage culvert and the 25 Providence Street property. Photograph taken facing east.

Station Location	Location Description/Rationale	Sample Depth* (inches)	Water Depth (inches)	COC Sample No.	Date and Time (hours)	Analysis	Sample Description
MATRIX: Sediment							
SD-08	Grab sediment sample collected from north-central portion of property from the small ponded water area adjacent to a concrete drainage culvert and the 25 Providence Street property boundary, to determine the presence of hazardous substances. 42.014943436 North Latitude 71.579556793 West Longitude	0-12	0	R01-160906MB-0030	9/12/2016 1643	VOCs	Sample was collected using a hand auger. Material described as dark brown, fine-to-medium SAND, little coarse gravel, trace organics (leaf debris). No water quality measurements were taken at this location due to lack of water. PID = 0.0 ppm.
SD-09	Field duplicate sample of SD-08, collected for quality control.	0-12	0	R01-160906MB-0031	9/13/2016 1643	VOCs	See sediment sample SD-08 for sample description.

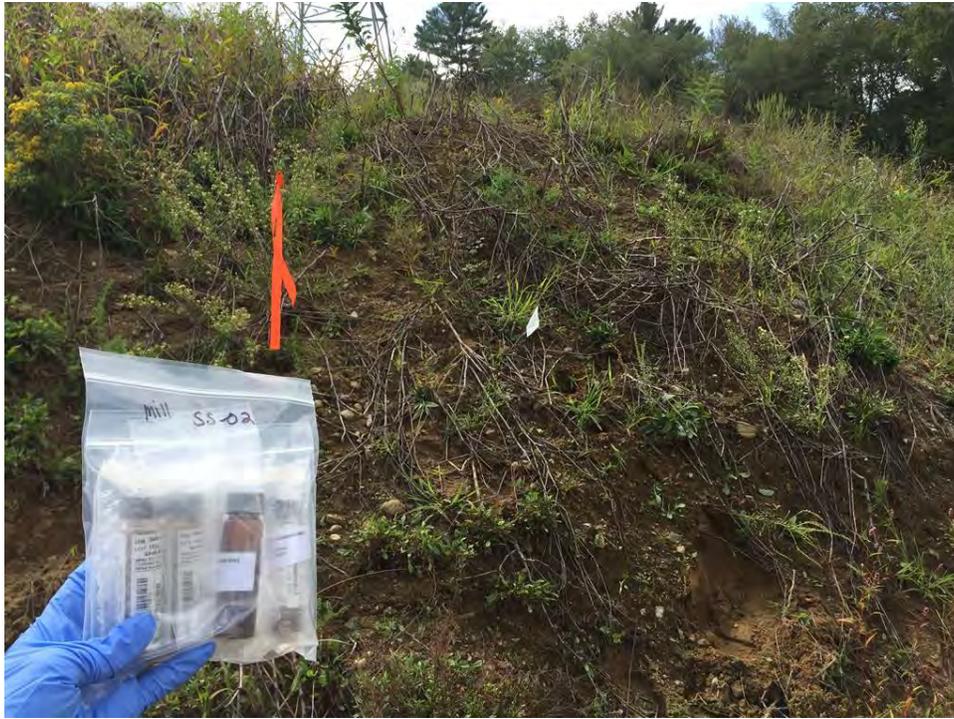
SCENE: View of soil/source sample location SS-02 within alleged off-site waste material. Photograph taken facing north.

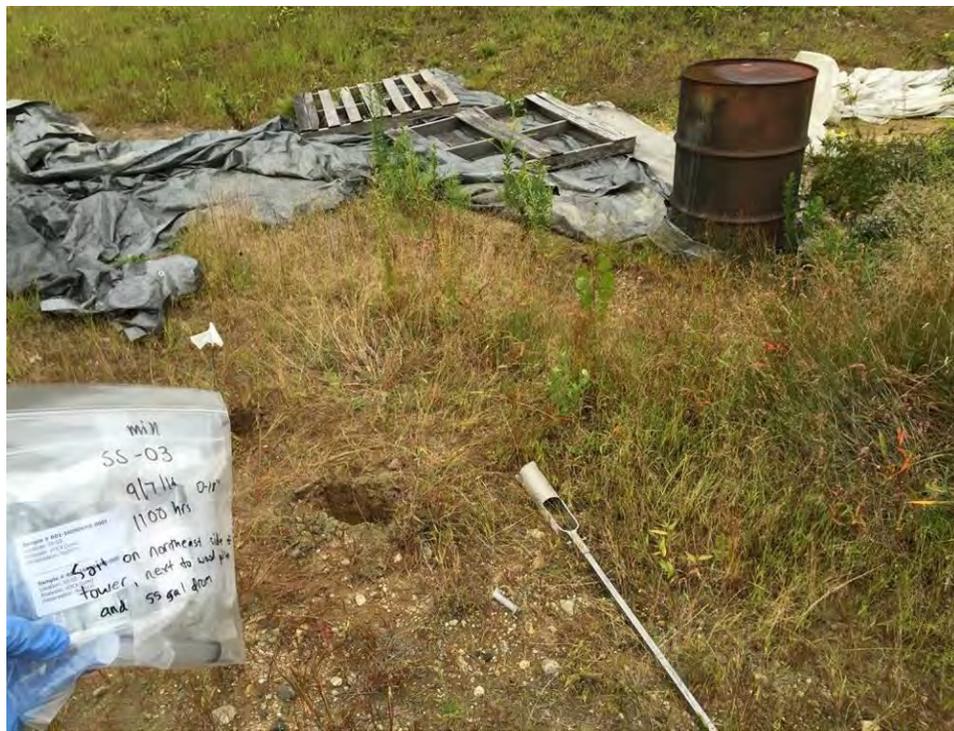
SCENE: View of soil/source sample location SS-03 in center portion of site. Photograph taken facing east.

SS-03	Soil/source sample collected from the central portion of the property adjacent to 55-gallon drums, to determine the presence of hazardous substances. 42.014827963 North Latitude 71.579962253 West Longitude	18	R01-160906MB-0003	9/7/2016 11:00	VOCs	Sample was collected using a hand auger. Material was described as brown, fine-to-medium SAND, little fine-to-medium gravel. CGI/O ₂ (LEL/%) = NR; PID = 0.0 ppm.
SS-04	Soil/source sample collected from the central portion of the property within work area near the base of the high-tension transmission tower, allegedly containing material from a former off-site waste site, to determine the presence of hazardous substances. 42.014481214 North Latitude 71.580203272 West Longitude	28	R01-160906MB-0004	9/7/2016 10:49	VOCs	Sample was collected using a hand auger. Material was described as dark brown, SILT and fine-to-coarse SAND. CGI/O ₂ (LEL/%) = NR; PID = 0.0 ppm.

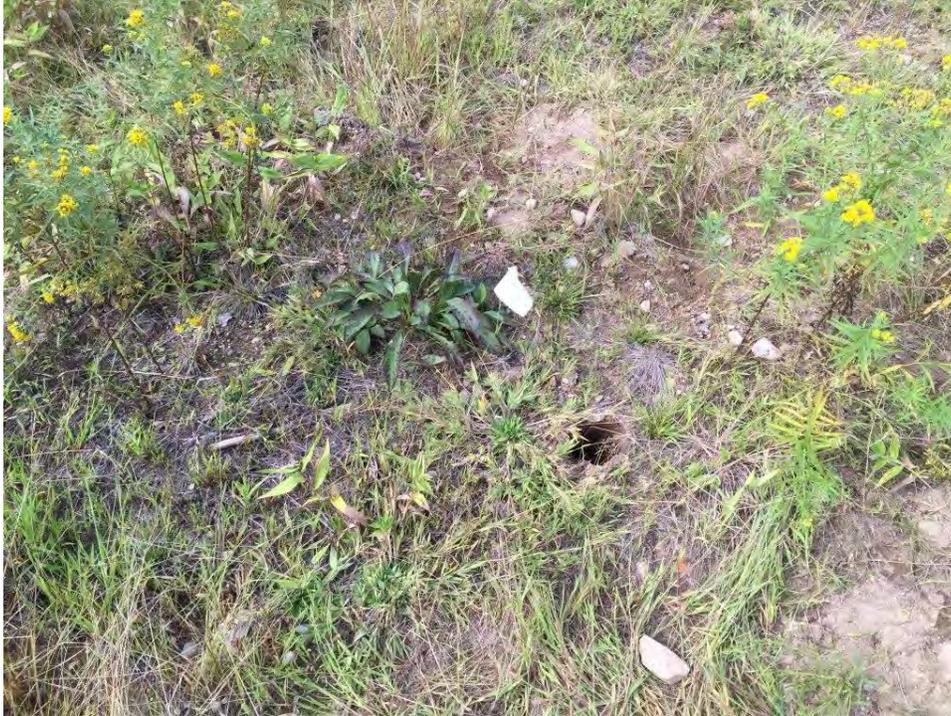
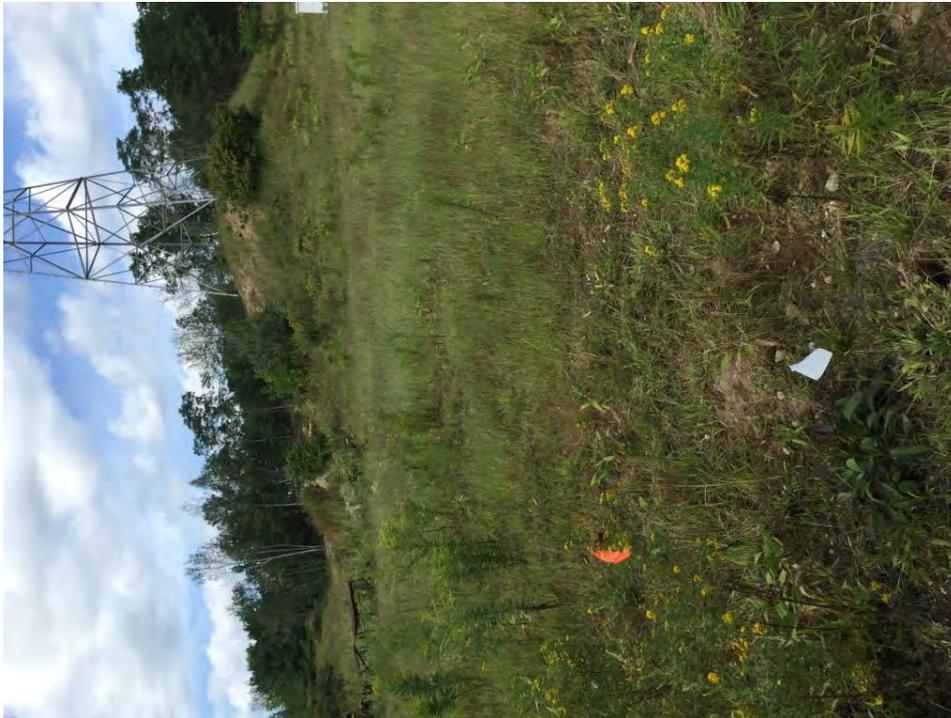
SCENE: View of soil sample location SS-04.

SCENE: View of soil sample location SS-04. Note high tension transmission tower. Photograph taken facing northwest.
