**FINAL REPORT
FOR
MILLVILLE TCE
PRELIMINARY ASSESSMENT
MILLVILLE, MASSACHUSETTS**

Prepared For:
U.S. Environmental Protection Agency
Region I
Office of Site Remediation and Restoration
5 Post Office Square, Suite 100
Boston, MA 02109-3912

Submitted by:
Weston Solutions, Inc.
Region I
Superfund Technical Assessment and Response Team IV (START)
101 Billerica Avenue, Building 5, Suite 103
North Billerica, Massachusetts 01862
February 2017

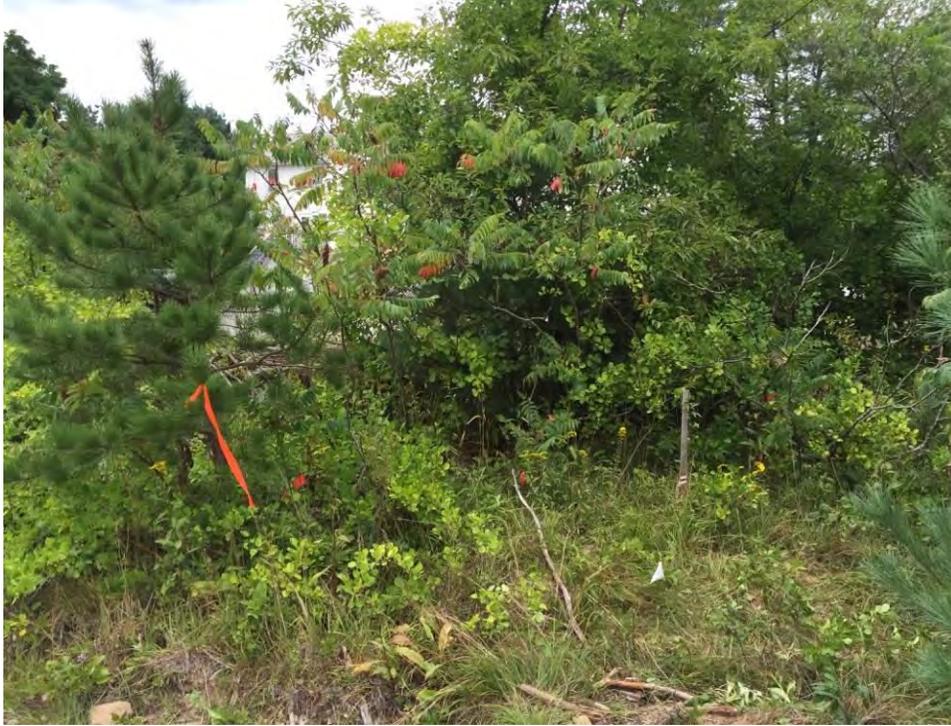
SCENE: View of soil sample location SS-05/SS-16. Note 19 Providence St. in background. Photograph taken facing east.

Station	Location Description/Rationale	Sample Depth (inches)	COC Sample No.	Date and Time (hours)	Analysis	Sample Description
MATRIX: Soil/Source						
SS-05	Soil/source sample collected from the northern property boundary abutting 25 Providence Street residence to the north, to determine the presence of hazardous substances. 42.014639229 North Latitude 71.579253928 West Longitude	10	R01-160906MB-0005	9/7/2016 13:15	VOCs	Sample was collected using a hand auger. Material was described as light brown, fine-to-medium SAND, some coarse gravel. CGI/O ₂ (LEL/%) = NR; PID = 0.0 ppm.
SS-06	Soil/source sample collected from the northern property boundary abutting 19 Providence Street residence to the north, near the contaminated drinking water supply well, to determine the presence of hazardous substances. 42.014357981 North Latitude 71.578844377 West Longitude	24	R01-160906MB-0006	9/7/2016 11:48	VOCs	Sample was collected using a hand auger. Material was described as light brown, fine-to-medium SAND, little medium gravel. CGI/O ₂ (LEL/%) = NR; PID = 0.0 ppm.

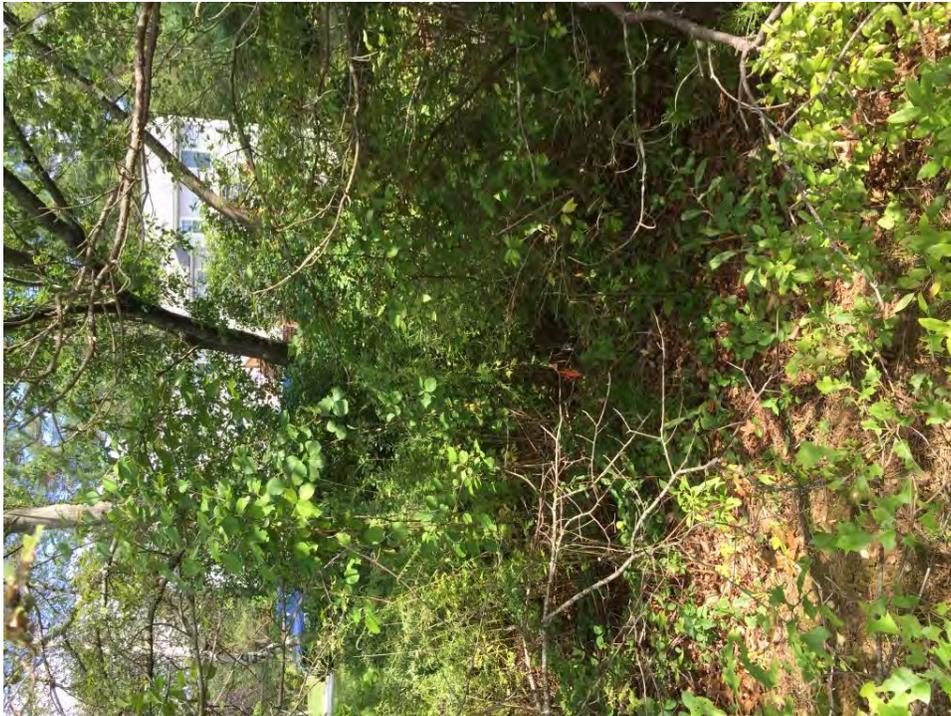
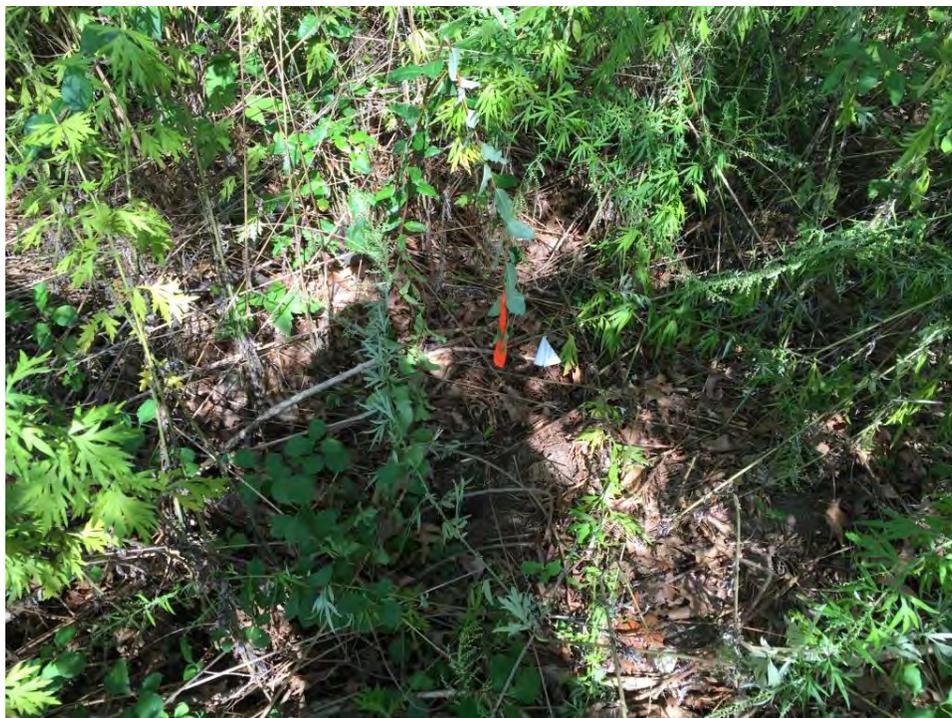
SCENE: View of soil sample location SS-06. Note 19 Providence St. in background. Photograph taken facing north.

SCENE: Closer view of soil sample location SS-06. Photograph taken facing north.

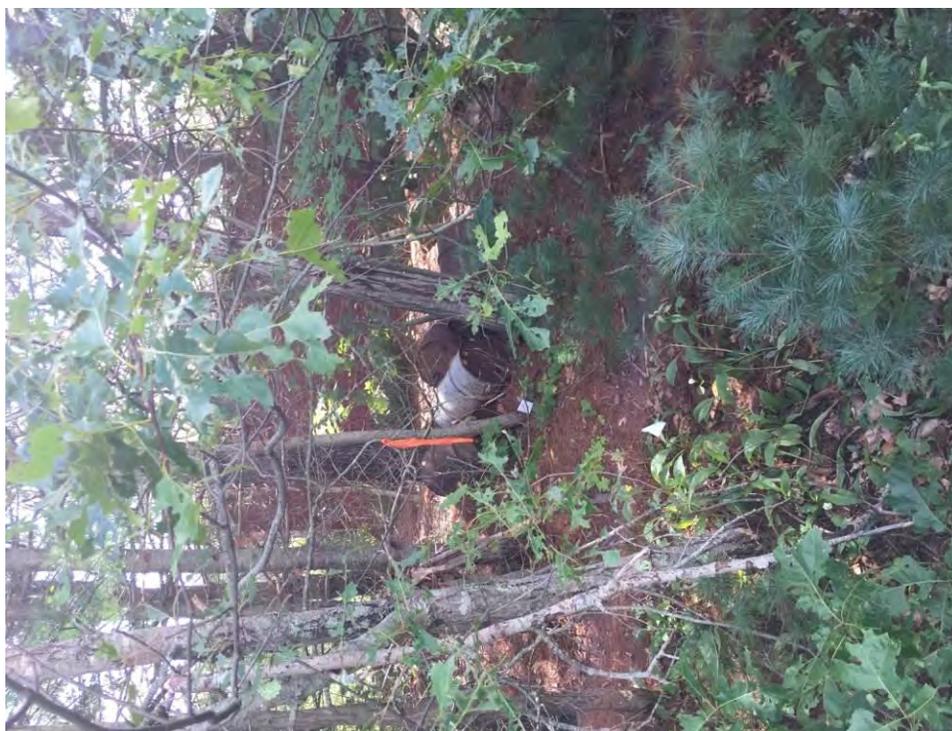
SCENE: View of soil sample location SS-07 collected near 30-gallon drums. Photograph taken facing east.

SS-07	Soil/source sample collected from the eastern property boundary adjacent to four 30-gallon drums on the adjacent property, to determine the presence of hazardous substances. 42.014198805 North Latitude 71.578868656 West Longitude	6	R01-160906MB-0007	9/7/2016 11:31	VOCs	Sample was collected using a disposable scoop. Material was described as light brown, fine SAND, little medium gravel, trace organics. CGI/O ₂ (LEL/%) = NR; PID = 0.0 ppm.
SS-08	Soil/source sample collected from the soil/road construction debris pile along the southeastern property boundary, to determine the presence of hazardous substances. 42.013982009 North Latitude 71.579253128 West Longitude	24	R01-160906MB-0008	9/7/2016 11:30	VOCs	Sample was collected using a hand auger. Material was described as light brown, fine-to-medium SAND, some coarse gravel. CGI/O ₂ (LEL/%) = NR; PID = 0.0 ppm.

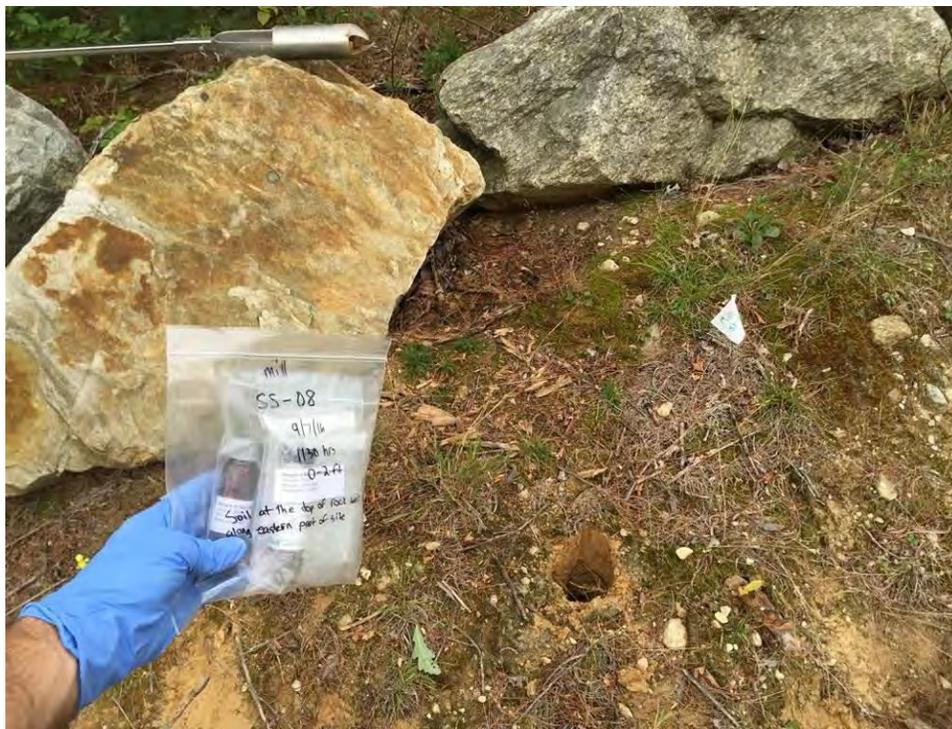
SCENE: View of soil/source sample location SS-08 in soil/road construction debris pile. Photograph taken facing southeast.

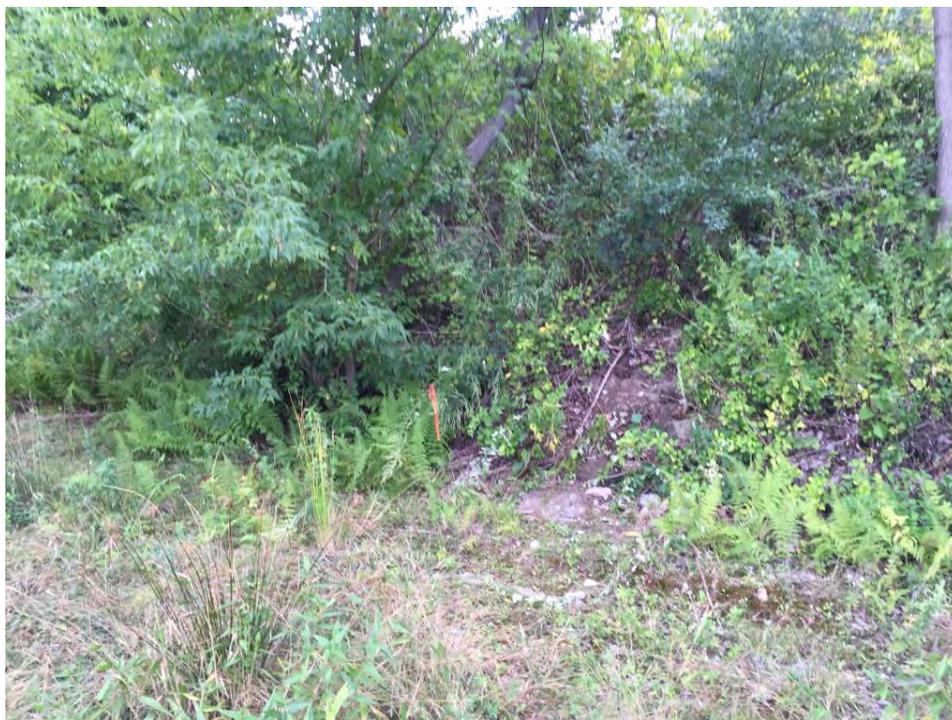
SCENE: View of soil/source sample location SS-09 in soil/road construction debris pile. Photograph taken facing south.

Station Location	Location Description/Rationale	Sample Depth (inches)	COC Sample No.	Date and Time (hours)	Analysis	Sample Description
MATRIX: Soil/Source						
SS-09	Soil/source sample collected from the soil/road construction debris pile along the southeastern property boundary, to determine the presence of hazardous substances. 42.013949051 North Latitude 71.579610743 West Longitude	24	R01-160906MB-0009	9/7/2016 11:02	VOCs	Sample was collected using a metal scoop. Material was described as light brown, fine-to-medium SAND, some coarse gravel, little debris (asphalt, concrete, and ceramic). CGI/O ₂ (LEL/%) = NR; PID = 0.0 ppm.
SS-10	Soil/source sample collected from the soil/road construction debris pile along the southeastern property boundary, to determine the presence of hazardous substances. 42.013940056 North Latitude 71.580028512 West Longitude	36	R01-160906MB-0010	9/7/2016 11:17	VOCs	Sample was collected using a hand auger. Material was described as light brown, fine-to-medium SAND, some coarse gravel. CGI/O ₂ (LEL/%) = NR; PID = NR.

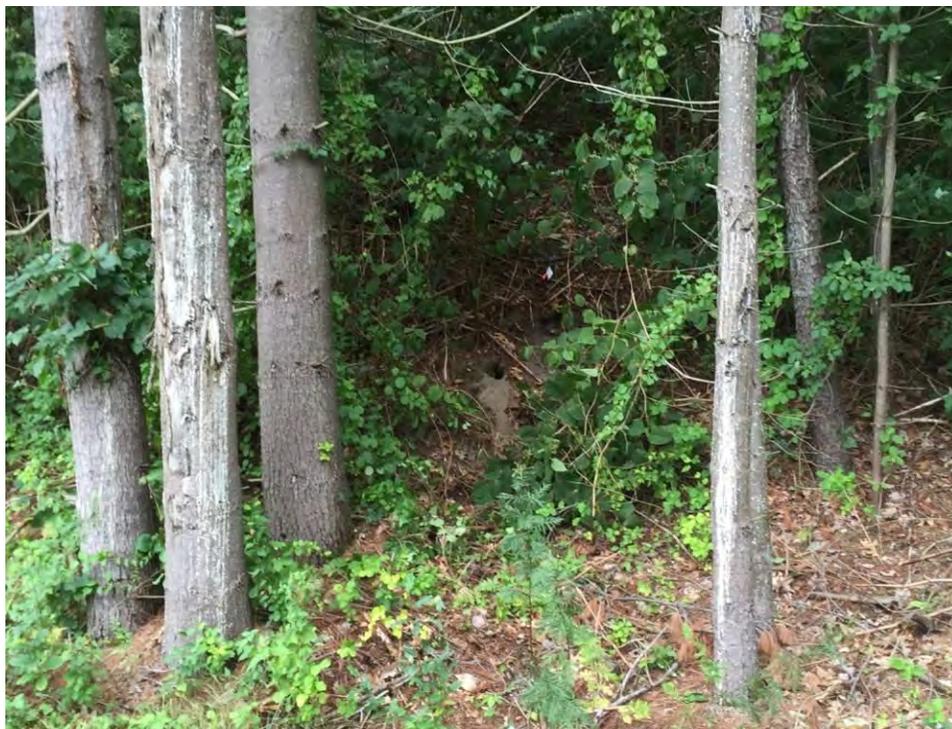
SCENE: View of soil sample location SS-10 in soil/road construction debris pile. Photograph taken facing south.

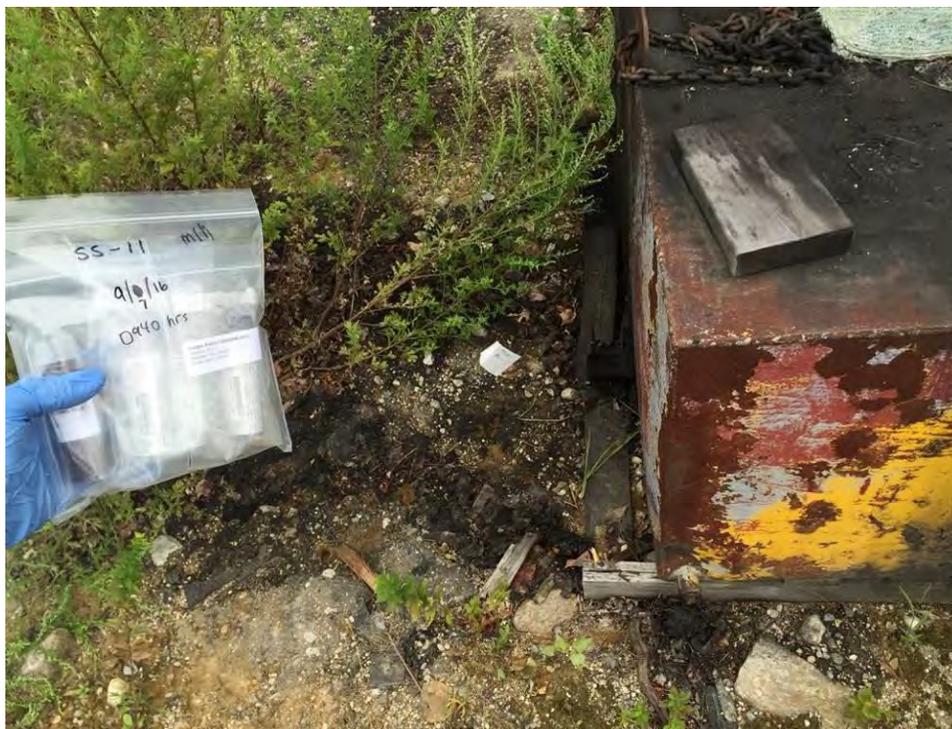
SCENE: View of soil/source sample location SS-11 in stained soil. Photograph taken facing east.

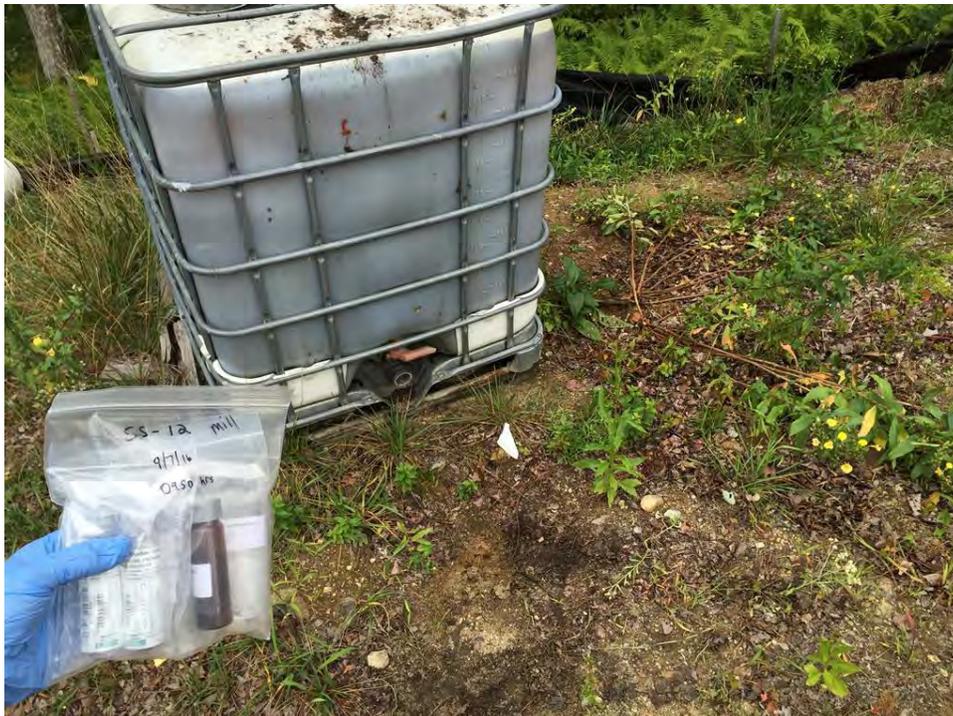
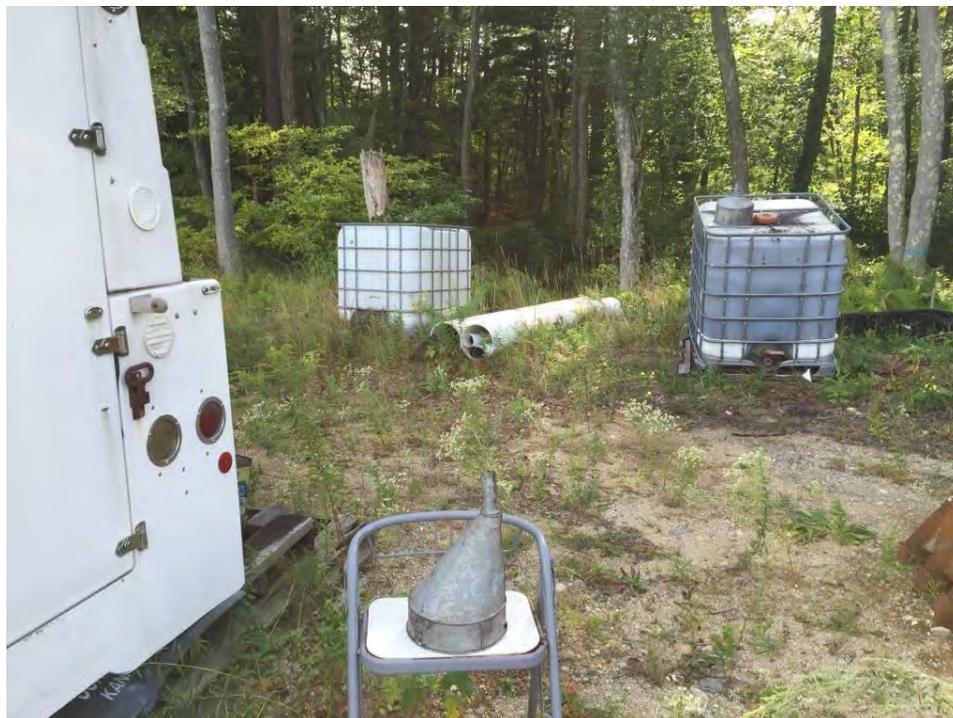
SCENE: View of soil/source sample location SS-12 adjacent 300-gallon tote. Photograph taken facing southwest.

SCENE: View of soil/source sample location SS-12 in background. Photograph taken facing southwest.

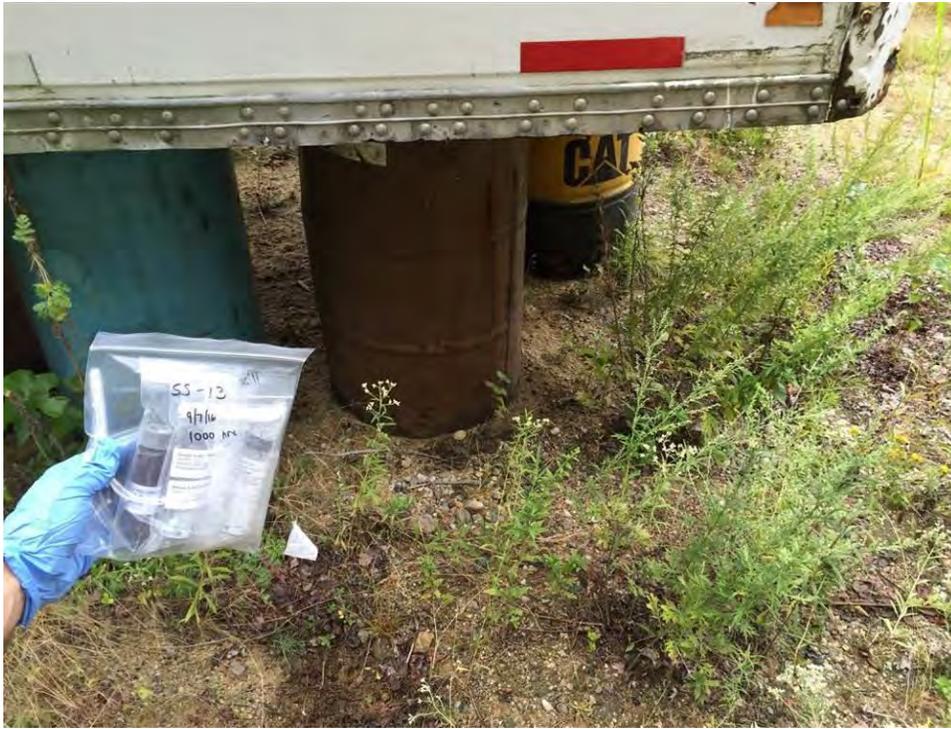
SCENE: View of soil/source sample location SS-13 in stained soil and drums under trailer. Photograph taken facing north.

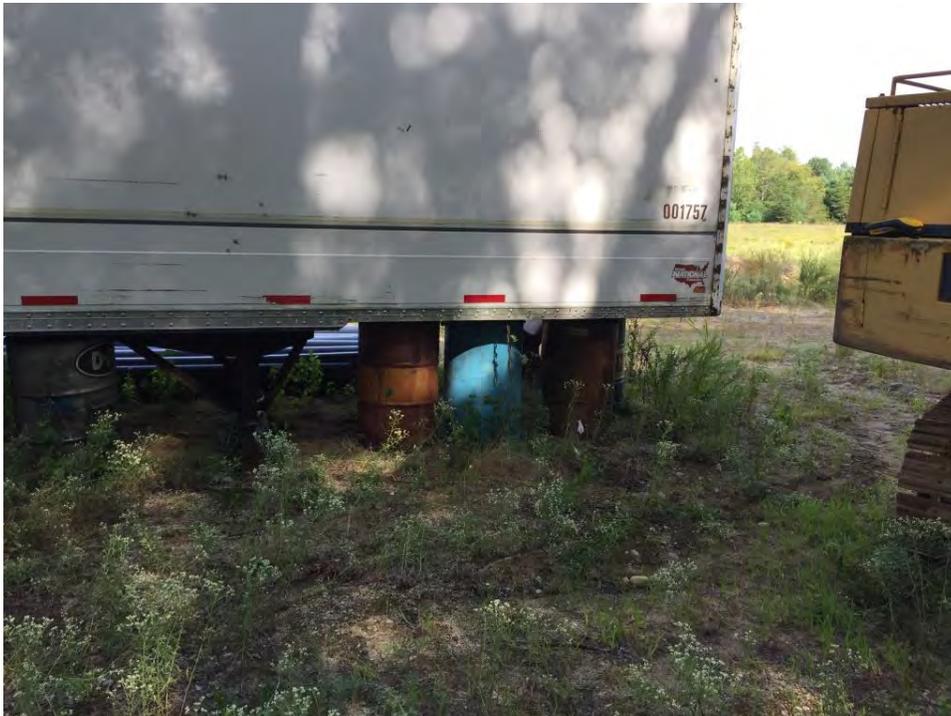
SCENE: View of soil/source sample location SS-13 and 55-gallon drums under trailer. Photograph taken facing north.

Station Location	Location Description/Rationale	Sample Depth (inches)	COC Sample No.	Date and Time (hours)	Analysis	Sample Description
MATRIX: Soil/Source						
SS-13	Soil/source sample collected from the central portion of the property adjacent to the 55-gallon drums located underneath the truck trailer, to determine the presence of hazardous substances. 42.014755597 North Latitude 71.580715464 West Longitude	3	R01-160906MB-0013	9/7/2016 10:08	VOCs	Sample was collected using a disposable scoop. Material was described as dark brown, medium-to-coarse SAND, little medium gravel, trace organics. CGI/O ₂ (LEL/%) = NR; PID = 0.0 ppm.
SS-14	Soil/source sample collected from the central portion of the property adjacent to the 300-gallon tote containers, to determine the presence of hazardous substances. 42.015094912 North Latitude 71.580875452 West Longitude	6	R01-160906MB-0014	9/7/2016 10:16	VOCs	Sample was collected using a disposable scoop. Material was described as . CGI/O ₂ (LEL/%) = 0/20.9; PID = 0.0 ppm.

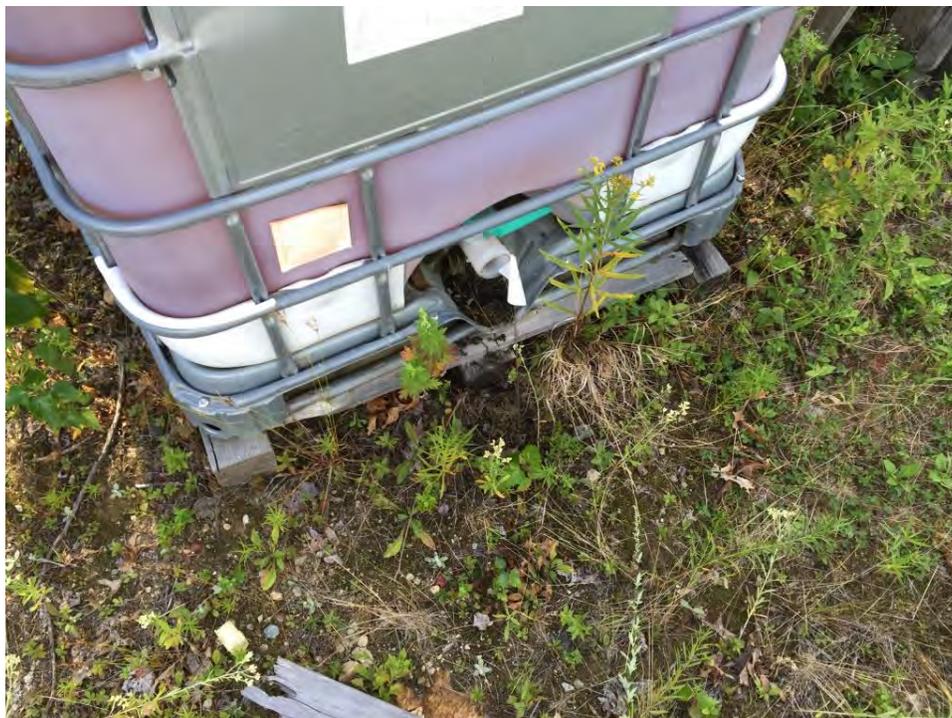
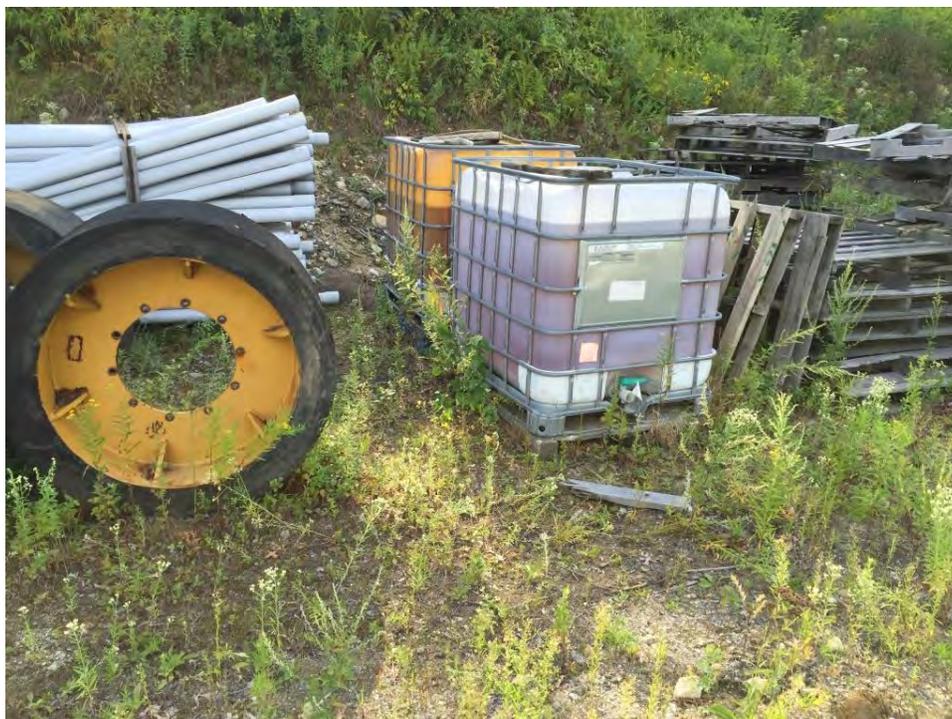
SCENE: View of soil/source sample location SS-14 adjacent 300-gallon tote. Photograph taken facing west.

SCENE: View of soil/source sample location SS-14. Photograph taken facing west.

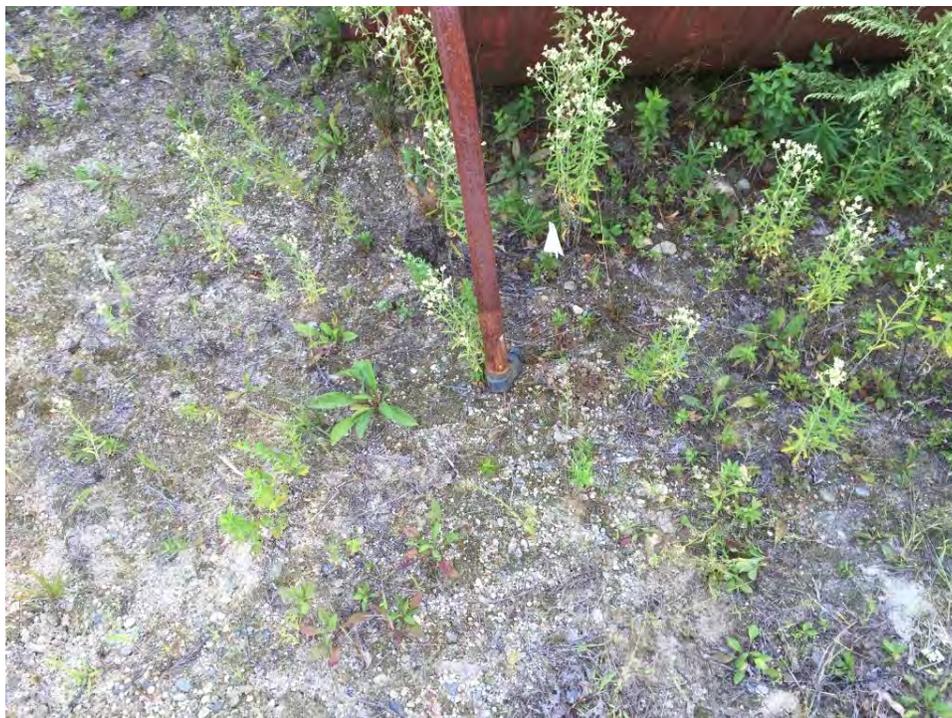
SCENE: View of soil/source sample location SS-15. Photograph taken facing southwest.

SS-15	Soil/source sample collected from the central portion of the property adjacent to the 1,000-gallon above ground storage tank, to determine the presence of hazardous substances. 42.015044805 North Latitude 71.580823628 West Longitude	6	R01-160906MB-0015	9/7/2016 10:10	VOCs	Sample was collected using a disposable scoop. Material was described as . CGI/O ₂ (LEL/%) = 0/20.9; PID = 0.0 ppm.
SS-16	Field duplicate sample of SS-05, collected for quality control .	6	R01-160906MB-0016	9/7/2016 13:15	VOCs	See sample description for SS-05.
SS-17	Soil/source sample collected from the northeastern portion of the Mendon St. Garage property, in front (east) of the on-site building, to determine the presence of hazardous substances. 42.014347332 North Latitude 71.577761233 West Longitude	24	R01-160906MB-0017	9/8/2016 10:57	VOCs	Sample was collected using a hand auger. Material was described as light brown, fine-to-medium SAND, little medium gravel. CGI/O ₂ (LEL/%) = 0/20.9; PID = 0.0 ppm.

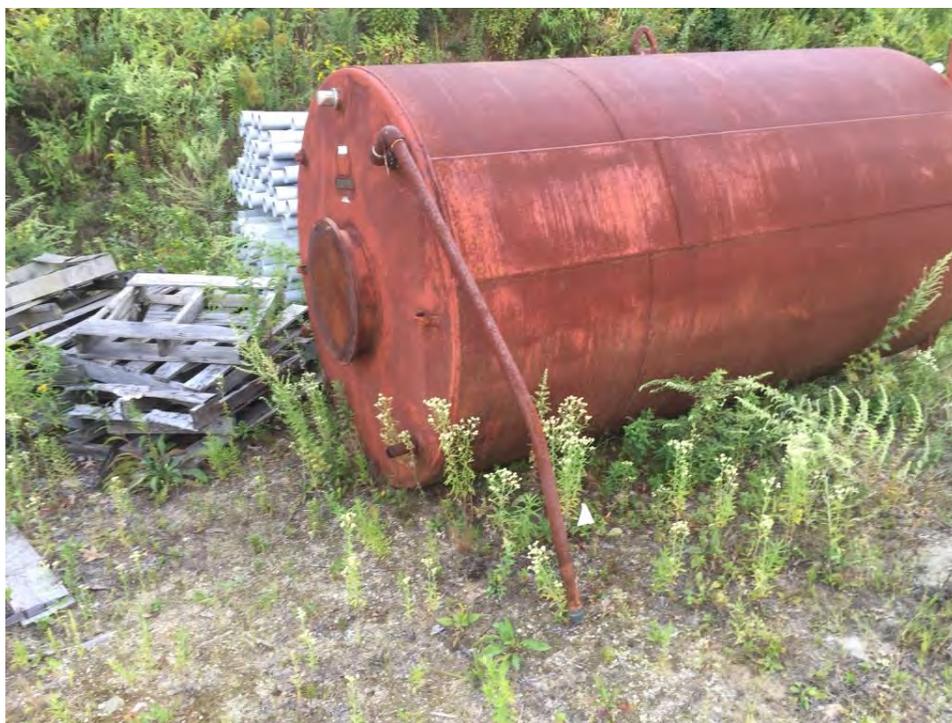
SCENE: View of soil/source sample location SS-15 adjacent 1,000-gallon (empty) Flammable Liquids aboveground storage tank (AST). Photograph taken facing west.

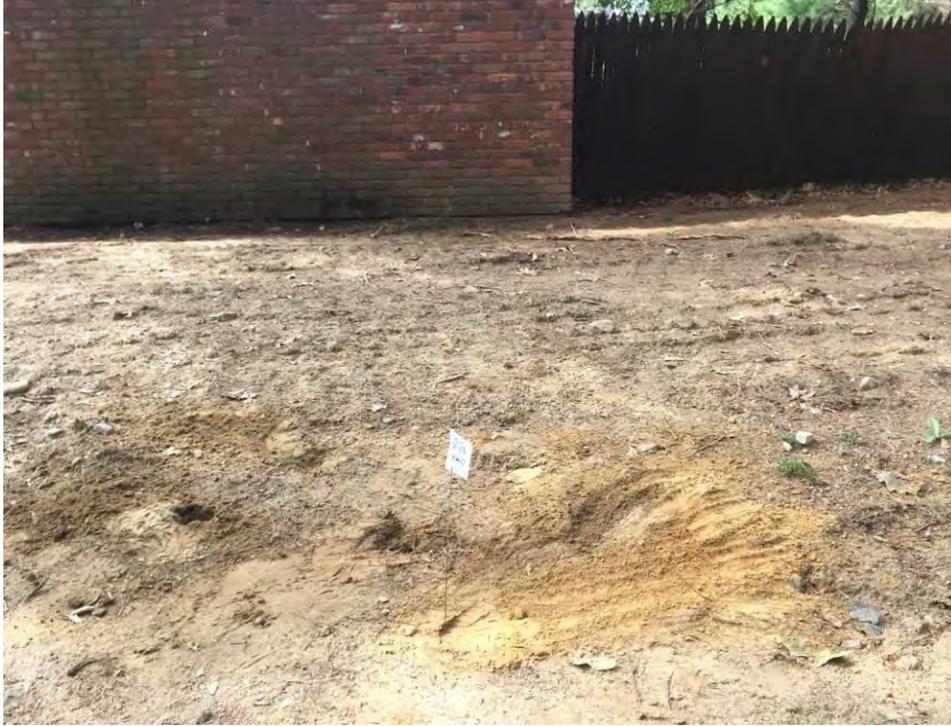
SCENE: View of soil sample location SS-17 in front of building. Photograph taken facing southwest.

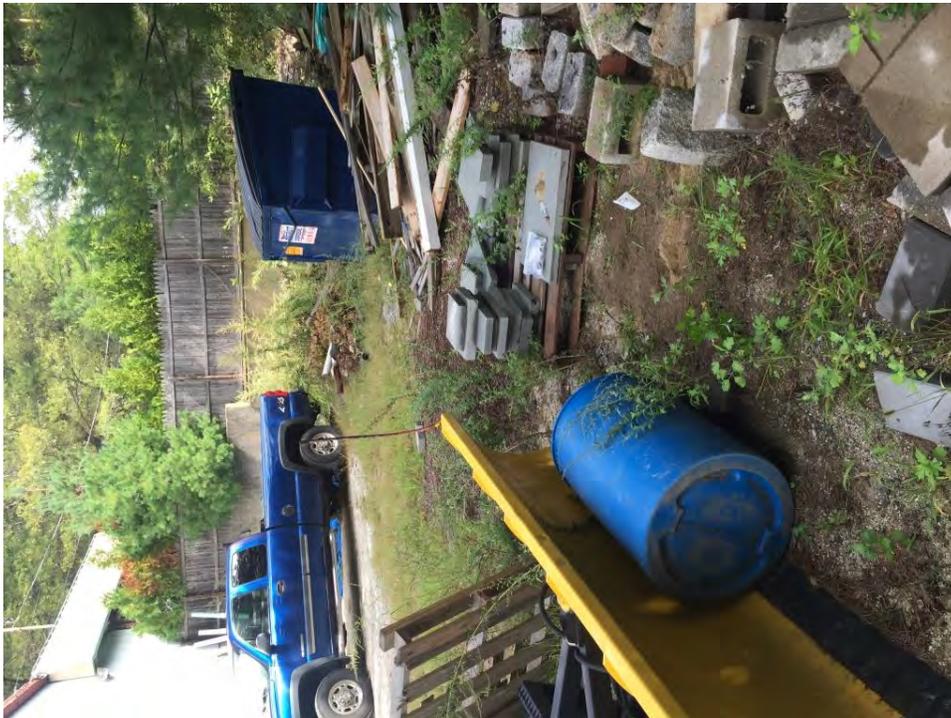
SCENE: View of soil sample SS-18 adjacent to single 55-gallon drum. Photograph taken facing north.

Station Location	Location Description/Rationale	Sample Depth (inches)	COC Sample No.	Date and Time (hours)	Analysis	Sample Description
MATRIX: Soil/Source						
SS-18	Soil/source sample collected from the eastern portion of the Mendon St. Garage property where vehicles/equipment are stored, adjacent to plow blade and an empty 55-gallon polyethylene drum, to determine the presence of hazardous substances. 42.014048779 North Latitude 71.577729896 West Longitude	18	R01-160906MB-0018	9/8/2016 11:00	VOCs	Sample was collected using a hand auger. Material was described as light brown, fine SAND, little coarse gravel. CGI/O ₂ (LEL/%) = 0/20.9; PID = 0.0 ppm.
SS-19	Soil/source sample collected from the southeastern portion of the Mendon St. Garage property where vehicles/equipment/supplies are stored, adjacent to three 55-gallon polyethylene drums, to determine the presence of hazardous substances. 42.013938734 North Latitude 71.57783086 West Longitude	13	R01-160906MB-0019	9/8/2016 11:00	VOCs	Sample was collected using a hand auger. Material was described as brown, SILT and SAND, little fine-to-coarse gravel. CGI/O ₂ (LEL/%) = 0/20.9; PID = 0.0 ppm.

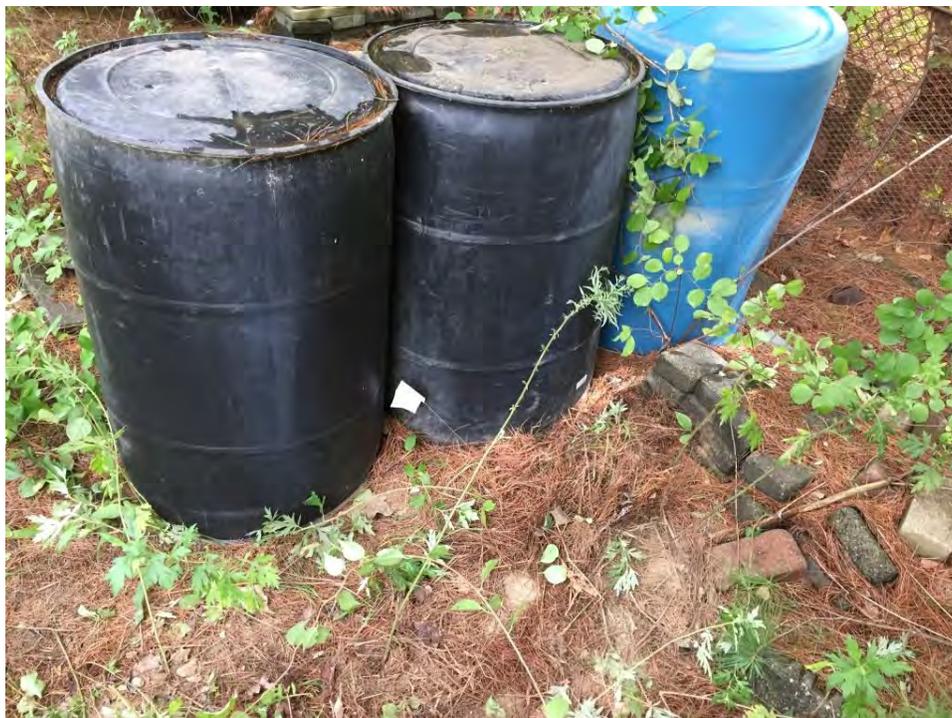
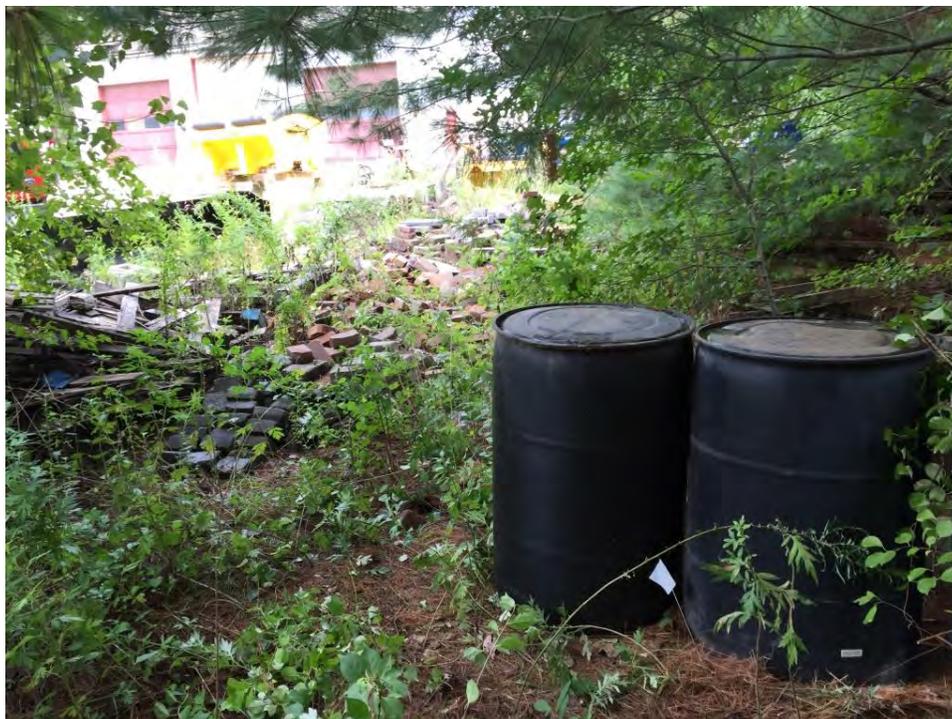
SCENE: View of soil sample SS-19 adjacent to three empty 55-gallon drums. Photograph taken facing east.

SCENE: View of soil/source sample location SS-19 adjacent to three empty 55-gallon drums. Photograph taken facing north.

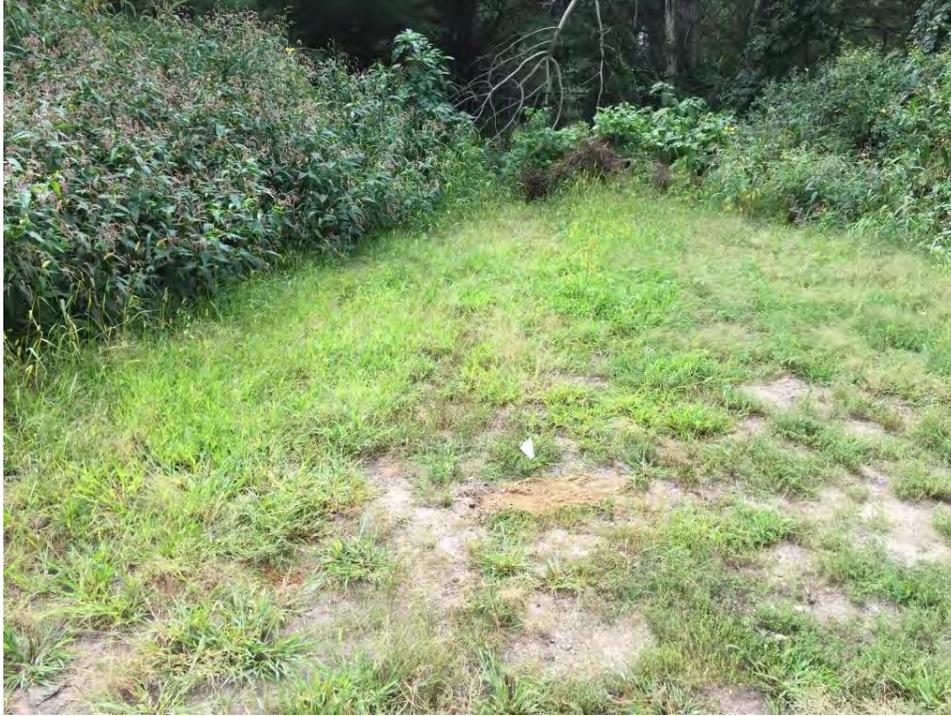
SCENE: View of soil/source sample location SS-20 in low-lying runoff area. Photograph taken facing south.

SS-20	Soil/source sample collected from the southern portion of the Mendon St. Garage property where yard waste/composite/mulch piles were located, in a low areas where water runs/settles from most of the lot, to determine the presence of hazardous substances. 42.013965451 North Latitude 71.577999611 West Longitude	12	R01-160906MB-0020	9/8/2016 11:27	VOCs	Sample was collected using a hand auger. Material was described as brown SILT, trace sand, trace. CGI/O ₂ (LEL/%) = 0/20.9; PID = 0.0 ppm.

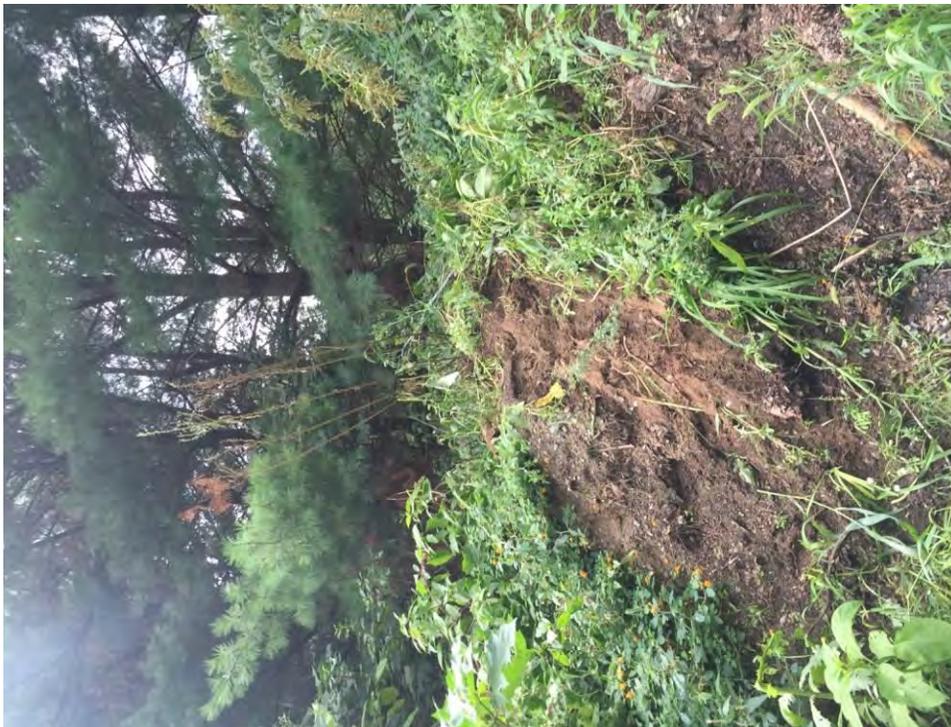
SCENE: View of soil sample location SS-21/SS-22 in yard waste/composite/mulch pile. Photograph taken facing south.

Station Location	Location Description/Rationale	Sample Depth (inches)	COC Sample No.	Date and Time (hours)	Analysis	Sample Description
MATRIX: Soil/Source						
SS-21	Soil/source sample collected from the southwestern portion of the property from a yard waste/composite/mulch soil pile, to determine the presence of hazardous substances. 42.014000493 North Latitude 71.578234895 West Longitude	30	R01-160906MB-0021	9/8/2016 11:23	VOCs	Sample was collected using a hand auger. Material was described as brown, fine-to-medium SAND, trace medium gravel, trace debris (plastic, brick). CGI/O ₂ (LEL/%) = 0/20.9; PID = 0.0 ppm.
SS-22	Field duplicate sample of SS-21, collected for quality control .	30	R01-160906MB-0022	9/8/2016 11:23	VOCs	See sample description for SS-21.
SS-23	Soil/source sample collected from the central portion of the property, from a soil pile allegedly containing material from a former off-site waste site, to determine the presence of hazardous substances. 42.014972103 North Latitude 71.579893146 West Longitude	36	R01-160906MB-0047	9/7/2016 11:52	VOCs	Sample was collected using a hand auger. Material was described as light brown, fine-to-coarse SAND, little medium gravel. CGI/O ₂ (LEL/%) = 0/20.9; PID = 0.0 ppm.

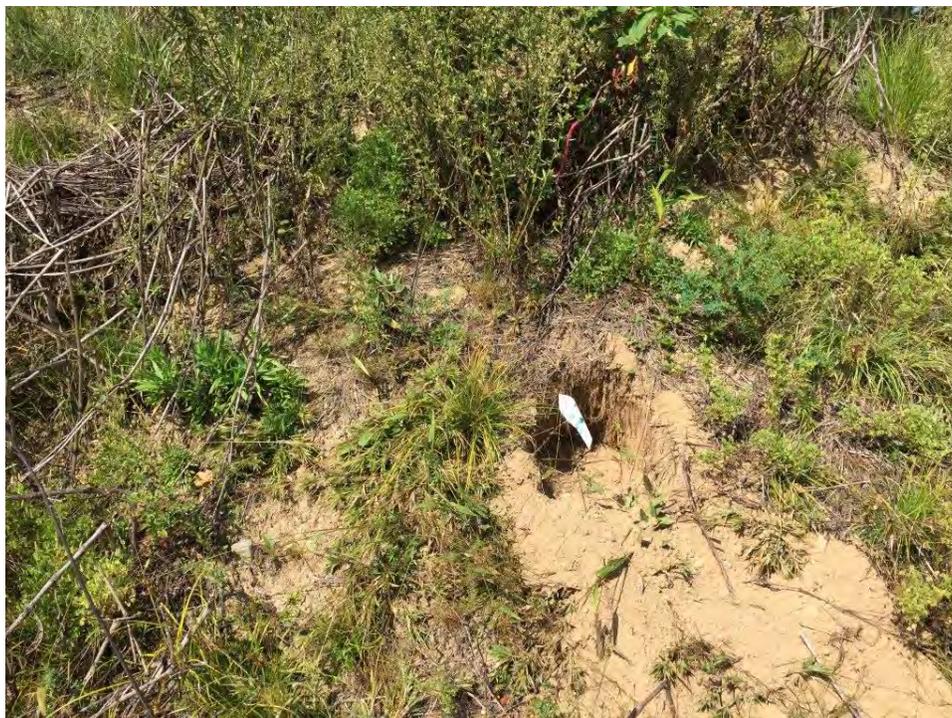
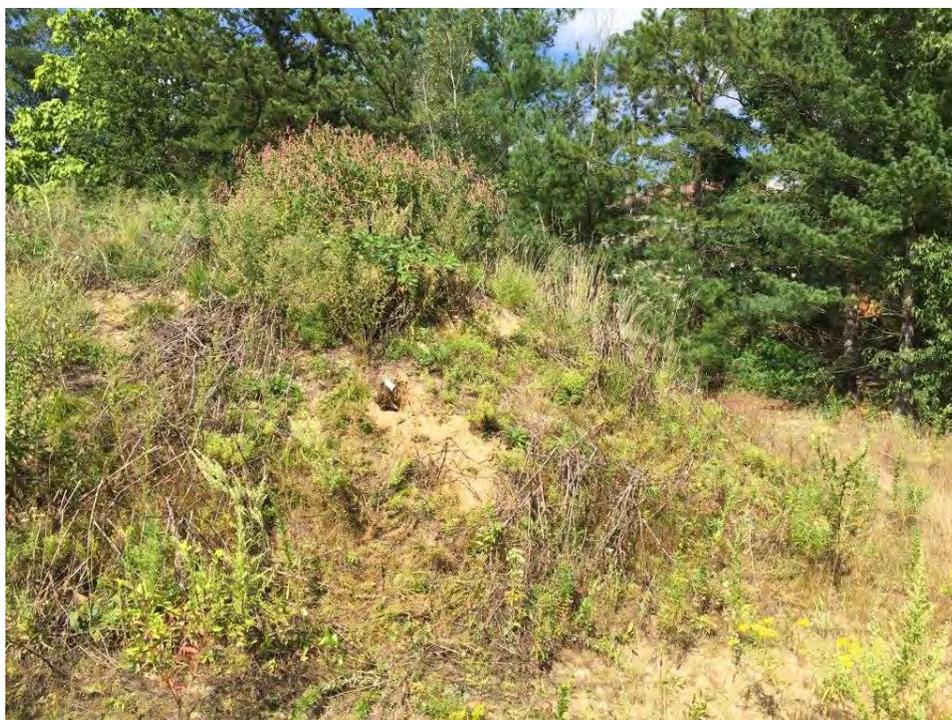
SCENE: View of soil/source sample location SS-23 allegedly within off-site waste material. Photograph taken facing north.

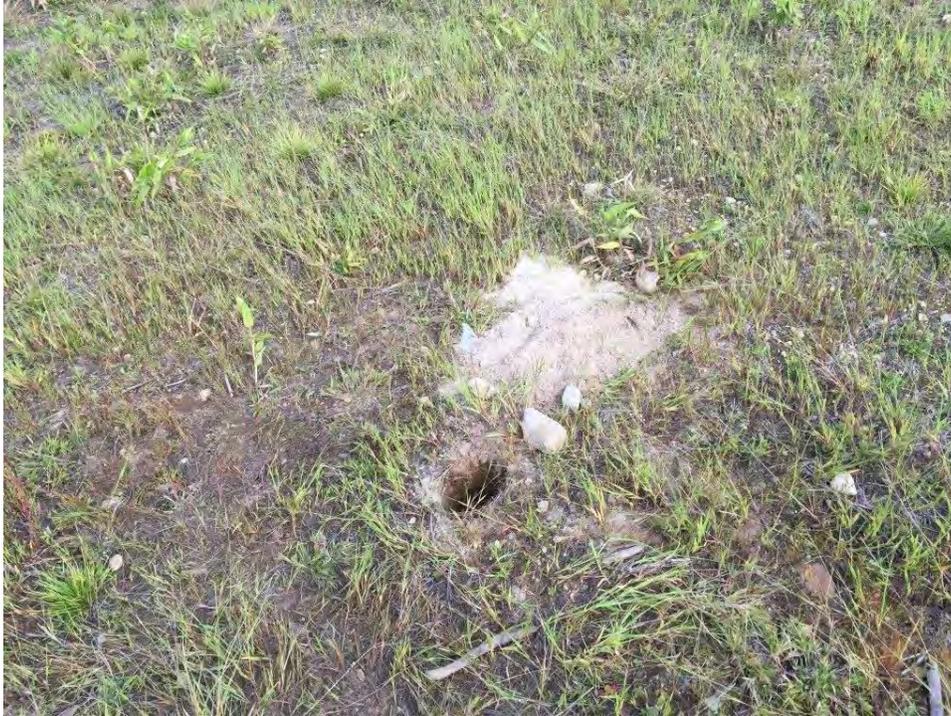
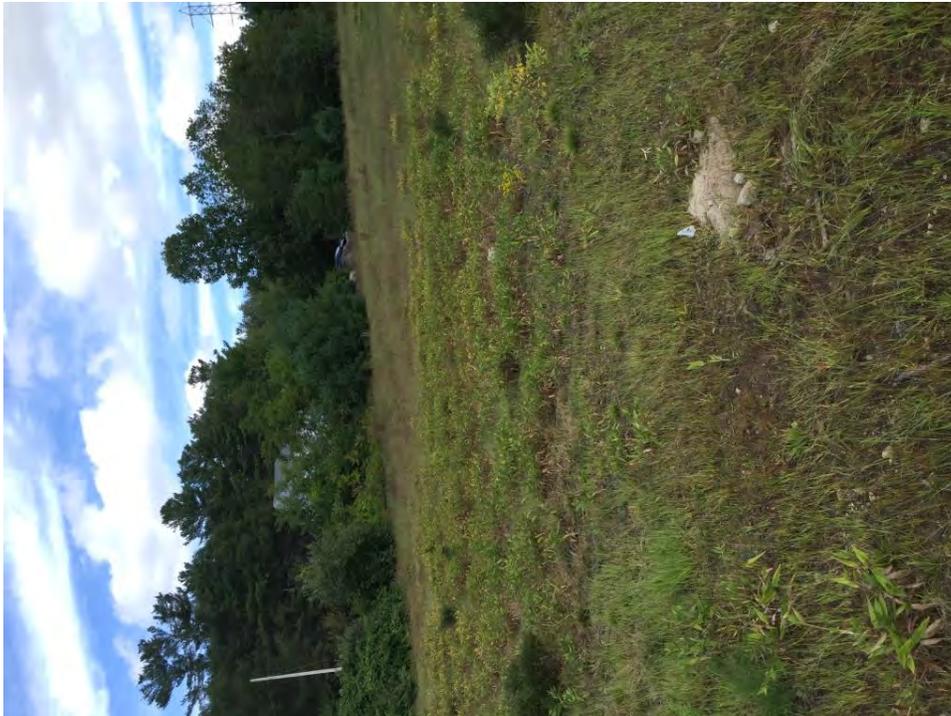
SCENE: View of soil/source sample location SS-24 allegedly within off-site waste material.

SCENE: View of soil/source sample location SS-24 in open, cleared area. Photograph taken facing northeast.

SS-24	Soil/source sample collected from the central portion of the property, from a soil pile allegedly containing material from a former off-site waste site, to determine the presence of hazardous substances. 42.014628362 North Latitude 71.579713418 West Longitude	24	R01-160906MB-0048	9/7/2016 11:28	VOCs	Sample was collected using a hand auger. Material was described as light brown, medium-to-coarse SAND, little coarse gravel, little cobble. CGI/O ₂ (LEL/%) = 0/20.9; PID = 0.0 ppm.
SS-25	Soil/source sample collected from oil-stained soil located on the south-central portion of the property, adjacent to partially excavated drainage pipes and the soil screener, to determine the presence of hazardous substances. 42.014739185 North Latitude 71.580554971 West Longitude	3	R01-160906MB-0049	9/7/2016 10:30	VOCs	Sample was collected using a disposable scoop. Material was described as dark brown, fine-to-coarse SAND, some medium gravel. CGI/O ₂ (LEL/%) = NR; PID = NR.

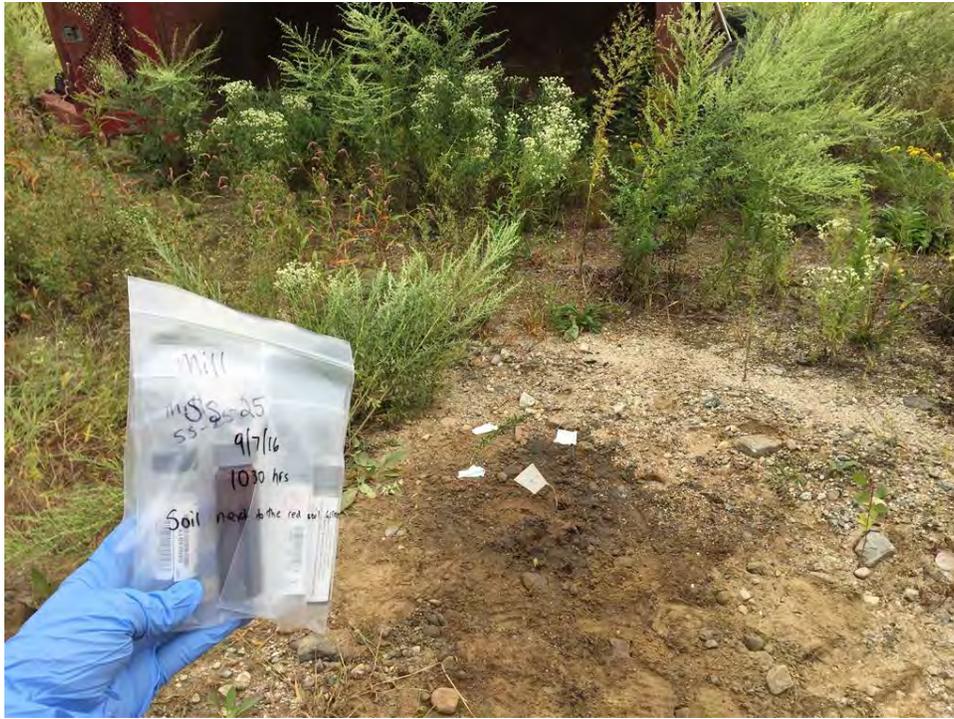
SCENE: View of soil/source sample location SS-25 in stained soil area near screener. Photograph taken facing north.

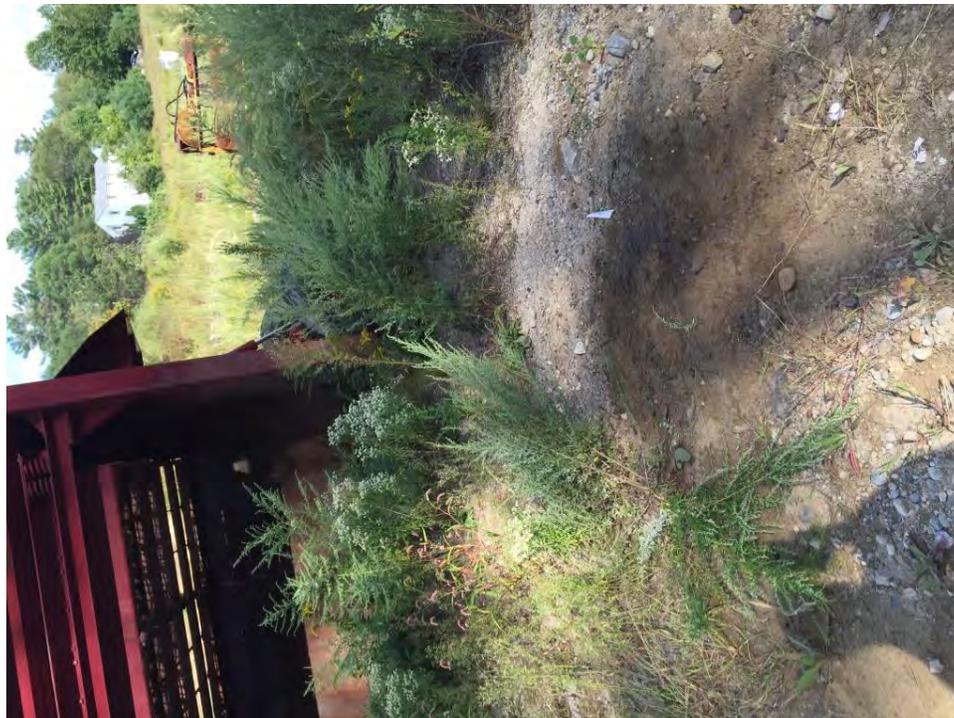
SCENE: View of soil/source sample location SS-25, screener to left. Photograph taken facing northeast.
