**FINAL REPORT
FOR
MILLVILLE TCE
PRELIMINARY ASSESSMENT
MILLVILLE, MASSACHUSETTS**

Prepared For:
U.S. Environmental Protection Agency
Region I
Office of Site Remediation and Restoration
5 Post Office Square, Suite 100
Boston, MA 02109-3912

Submitted by:
Weston Solutions, Inc.
Region I
Superfund Technical Assessment and Response Team IV (START)
101 Billerica Avenue, Building 5, Suite 103
North Billerica, Massachusetts 01862
February 2017

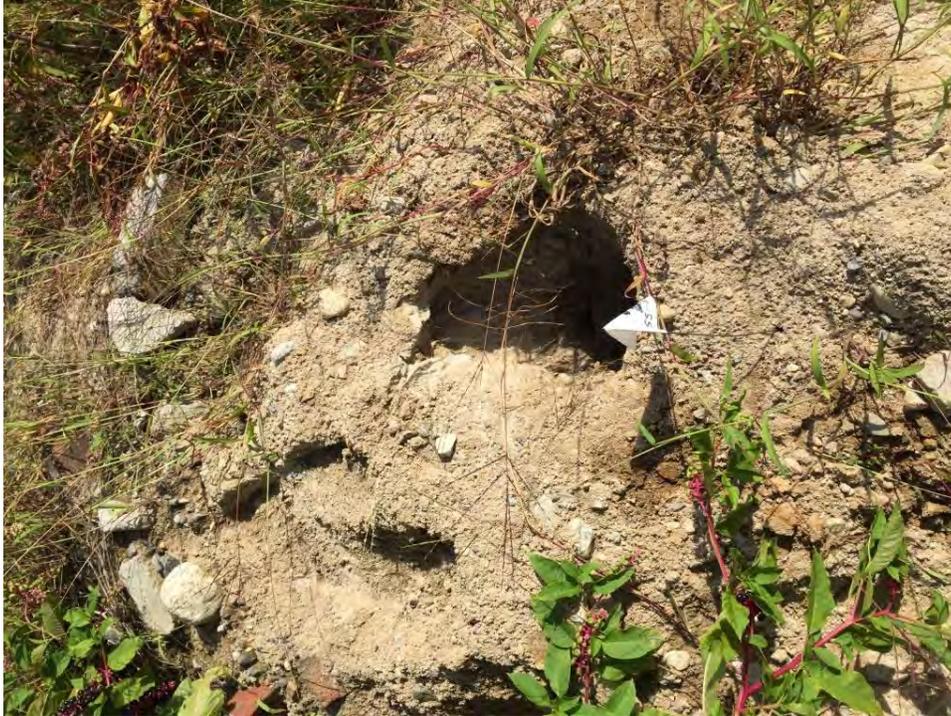
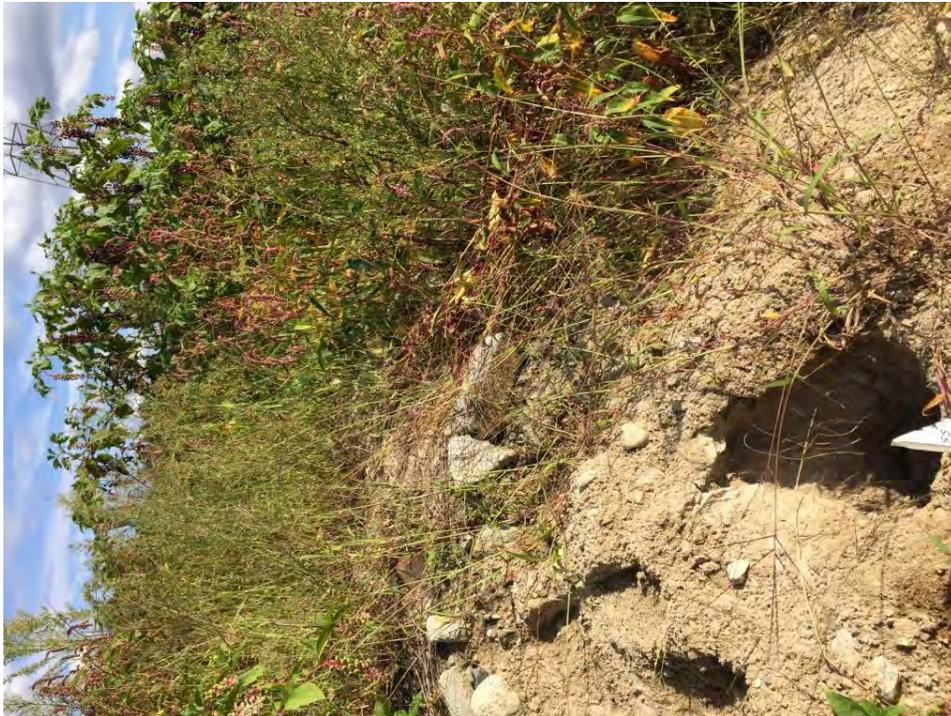
SCENE: View of soil/source sample location SS-26 allegedly within off-site waste. Photograph taken facing north.

Station Location	Location Description/Rationale	Sample Depth (inches)	COC Sample No.	Date and Time (hours)	Analysis	Sample Description
MATRIX: Soil/Source						
SS-26	Soil/source sample collected from the central portion of the property, from a soil pile allegedly containing material from a former off-site waste site, to determine the presence of hazardous substances. 42.015271076 North Latitude 71.580542985 West Longitude	24	R01-160906MB-0050	9/7/2016 13:04	VOCs	Sample was collected using a hand auger. Material was described as light brown, fine-to-medium SAND, some coarse gravel, some debris at surface (brick, concrete). CGI/O ₂ (LEL/%) = 0/20.9; PID = 0.0 ppm.
